AIO Card ASIC Digital Noise Modification

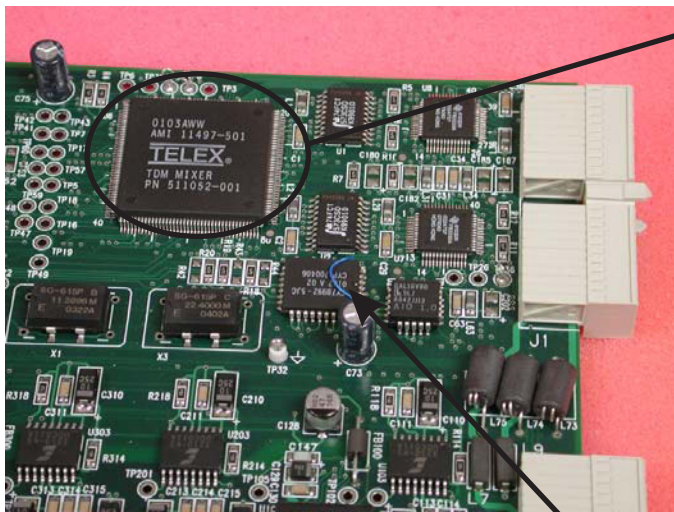
An audible “sizzling” or “frying” noise can be heard in port to port audio through the ADAM Matrix. This is more prevalent in end cards.

A timing problem exists in Telex TDM ASICs fabricated by AMI.

1. Using kynar or other suitable jumper wire, run a jumper from U5 pin 5 to U5 pin 30 as shown in the photo below.
2. Create a solder bridge between pins 28 and 29 on U5.

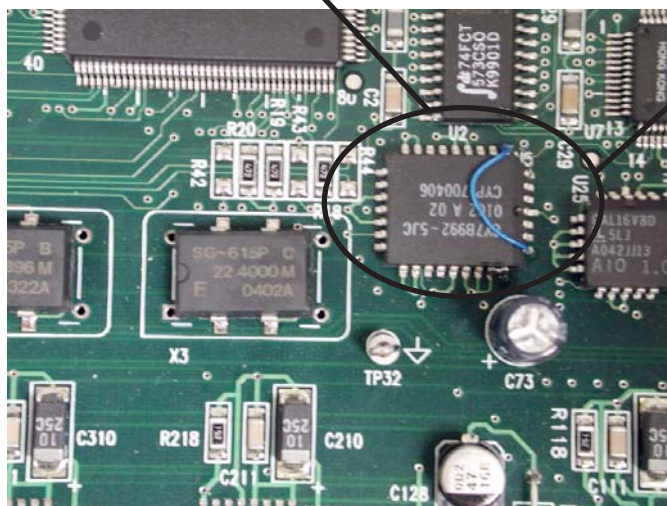
Area of interest

Note second line of text on ASIC starts with “AMI”.
