## Audio Noise in Systems mixing older 8-port Cards with TRIBUS / MADI / AIO-16s

# RTS™ TECHNICAL BULLETIN

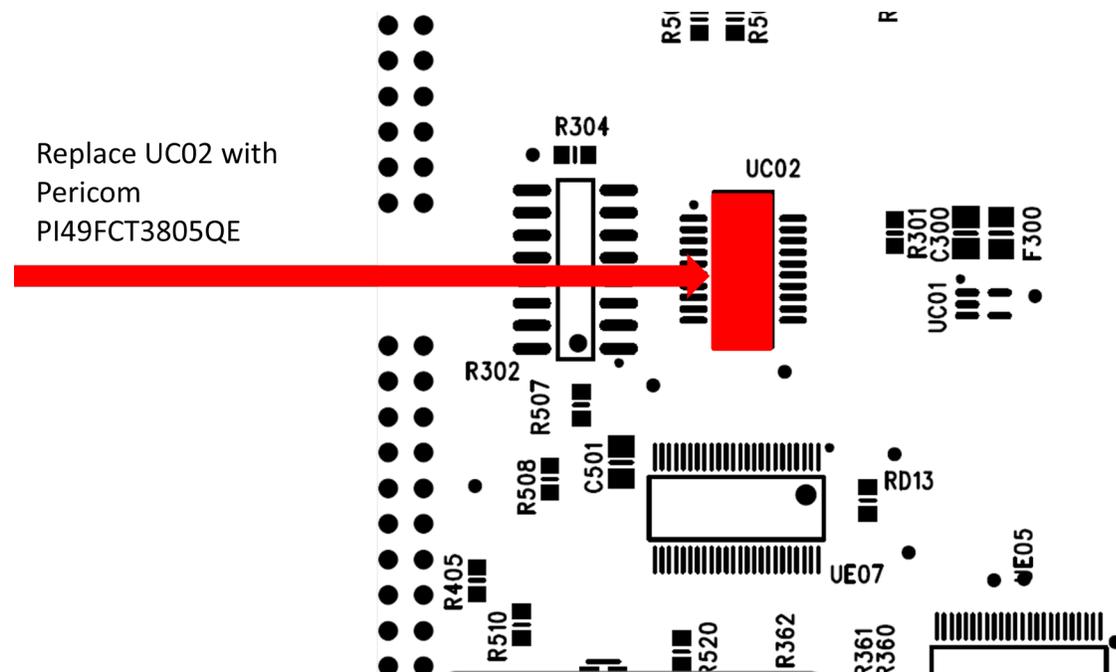
Engineering has become aware of several systems deployed at customer sites in which newer cards used as a clock master (specifically TRIBUS / MADI / AIO-16) have generated noise with older generation cards (AIO-8 / AES-3 / RVON-8 / DBX). This combination has produced audio noise on timeslots associated with the older generation cards.

The older system cards (AIO-8 / RVON-8 / AES-3 / DBX) all need to see an incoming clock reference that complies with 5 V CMOS thresholds (typically a logic high level of 3.6 Vdc or greater). The TRIBUS, MAD1 and AIO-16 cards all generate clock outputs which are TTL levels. These measure approximately 3 V in the lab but can be as low as 2.15 V depending upon signal integrity. The fact that these 3 newer cards do not drive clock reference levels appropriate for the older generation cards causes instability in the clocks received by the AIO-8 / RVON-8 / AES-3 / DBX cards. The instability creates jitter and sampling errors on the TDM bus. This introduces audible noise in the system.

In order to fix this problem, the clock drivers on the TRIBUS, MADI and AIO-16 must be replaced with a footprint compatible device capable of driving a 5 V compliant output. The TRIBUS and MADI cards currently use the same Front Card PCB layout, so both of these cards can be fixed by replacing UC02. For the AIO-16, UH01 needs to be replaced.

STEP 1: Remove UC02. Clean pads and install Pericom PI49FCT3805QE device.

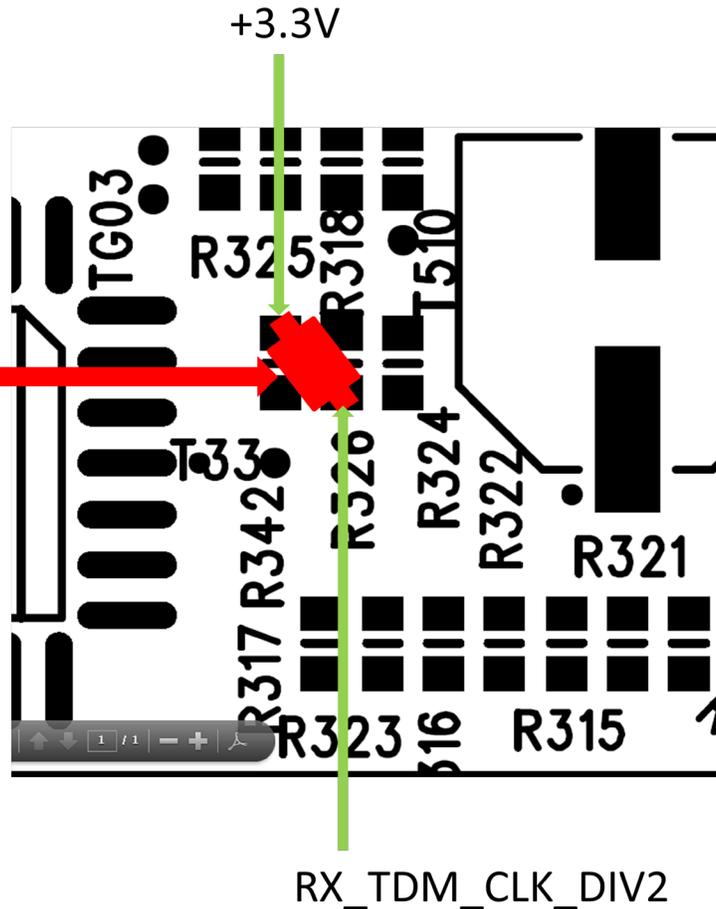
In the case of the TRIBUS and MADI designs, replacement of the clock driver device with a 5 V compliant output actually creates another issue which must be resolved. Every I/O card that is clock master also generates a reference clock onto the backplane which comes back into that card on backplane connector pin A20 as its own clock reference. In the case of the TRIBUS and MADI, this incoming clock reference goes through a 33 Ohm series resistor into an FPGA. The FPGA is designed for 3.3 V compliant inputs, but will tolerate levels up to 4.1 V maximum. The change to a 5 V output level will potentially damage these parts.

In order to mitigate this risk of damage, an additional diode clamp must be reworked onto the PCBA to limit the incoming clock reference level to the FPGA. This diode clamps the reference clock input to a level approximately a diode drop above 3.3 Vdc. This same risk is not present on the AIO-16 and does not need to be implemented.

STEP 2: Solder diode across following parts to clamp incoming clock reference signal to +3.3 Vdc rail:

Infineon  
BAT1503WE6327  
Schottky  
Clamp  
Diode  
SOD-323

Carefully place  
diode across R326  
and R342. Solder into  
position.

Cathode connects to  
+3.3V, anode connects  
to RX\_TDM\_CLK\_DIV2
