## AIO-16 Noise detected on Same Card Mixes / Cross-Connects

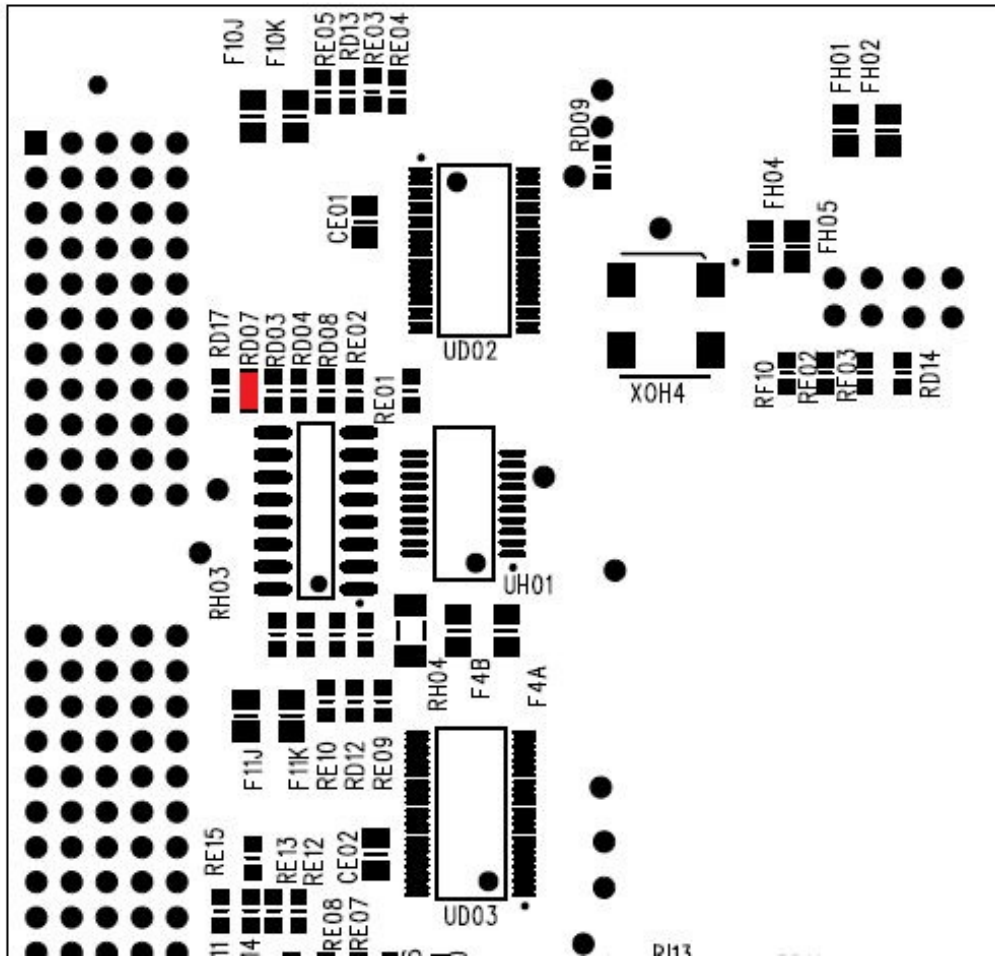
The root cause of this issue in timeslots cross-connected on the same card is that the data delay path is very low. HOLD time requirements are not satisfied for the TDM data being clocked back into the AIO-16 card. Data is improperly sampled and corrupt samples are passed through to the codecs and D/A converters. These are perceived as audible pops / clicks on the AIO-16 analog ports.

The data HOLD time requirement for the AIO-16 is approximately 1.1 nsec. In units where the audible noise is detected, the HOLD time is measured to be less 1 nsec. There is a programmable clock generation IC on the AIO-16 (and the other ADAM cards) which is responsible for the generation of the various sampling clocks in the design. These clock generation ICs allow for the phase delay of the outputs to be adjusted by resistor settings.

Specifically, installation of a zero Ohm 0603 size resistor (F.01U.162.707 or equivalent) in location RD07 will correct the problem. This produces a 2.8 nsec shift in the receive TDM sample clock and creates sufficient hold time to eliminate the improper sampling.

Install 0 Ohm resistor F.01U.162.767 in location RD07 (see diagram on following page). Note that this location should currently be unpopulated on an unmodified AIO-16. If the location already has a zero Ohm resistor, this indicates the card has already been corrected and re-tested.

Once the modification has been completed, the unit should be re-tested to insure the noise issue has been corrected and that the card is working properly.
