RTS-TB-015**11-January-2013****RVON-2 Mechanical Interference in DKP16 CLD assembly can create Unreliable Operation & DKP16 CLD 'Lock-Up'**

RTS™ TECHNICAL BULLETIN

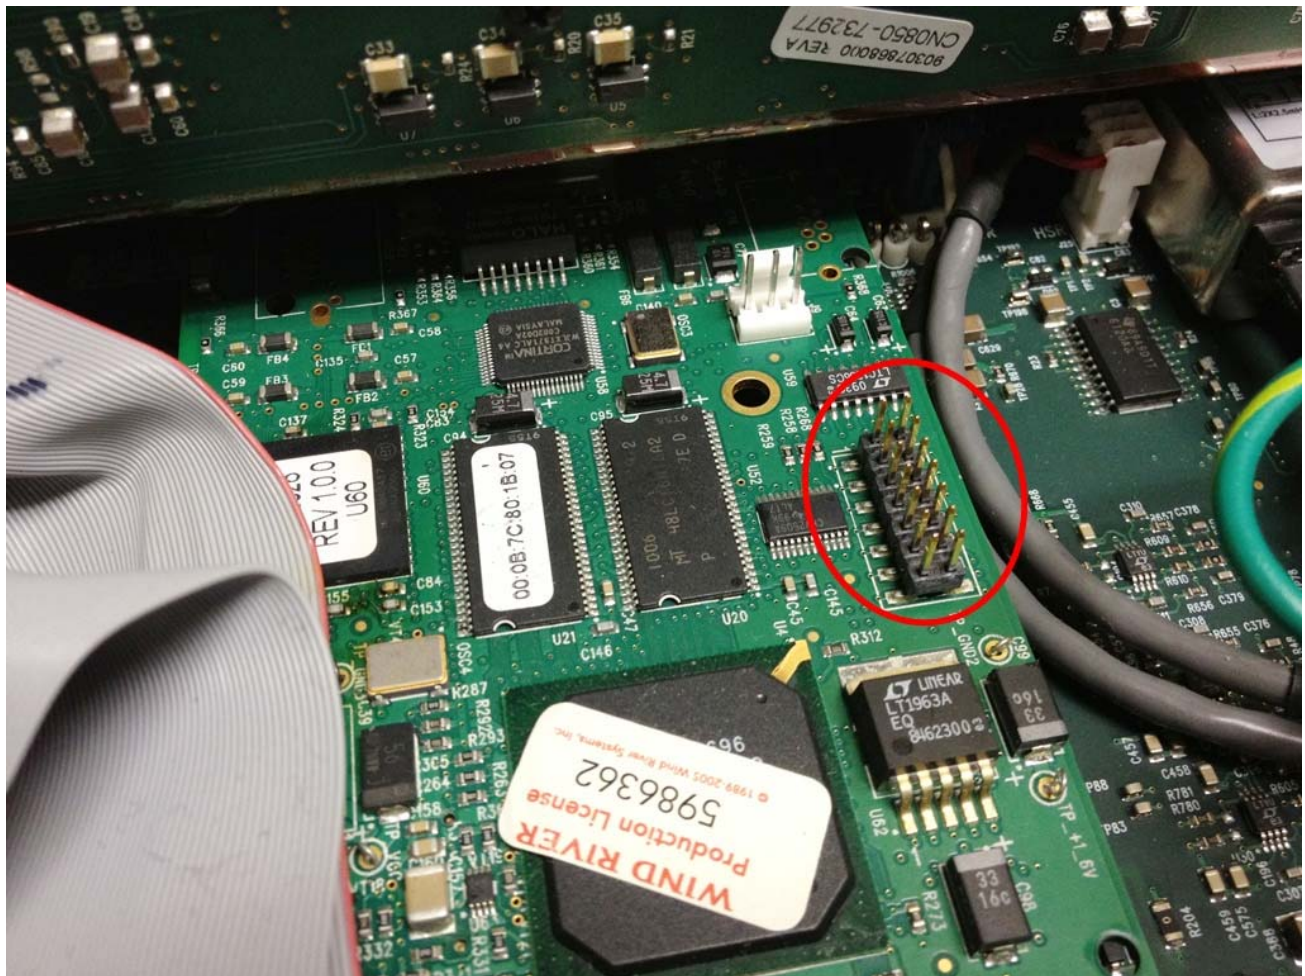
- The card is installed in a DKP16-CLD keypanel; **and**
- The card's programming header "J1" pushes against the metal heat shield of the keypanel's AC / DC power supply.

4. The RVON-2 card should be clearly visible within the unit along with programming header J1 (highlighted in the following photo).
