RTS-TB-018**23-April -2013****Audible Hum / Noise Emitted from KP-32 Family Displays**

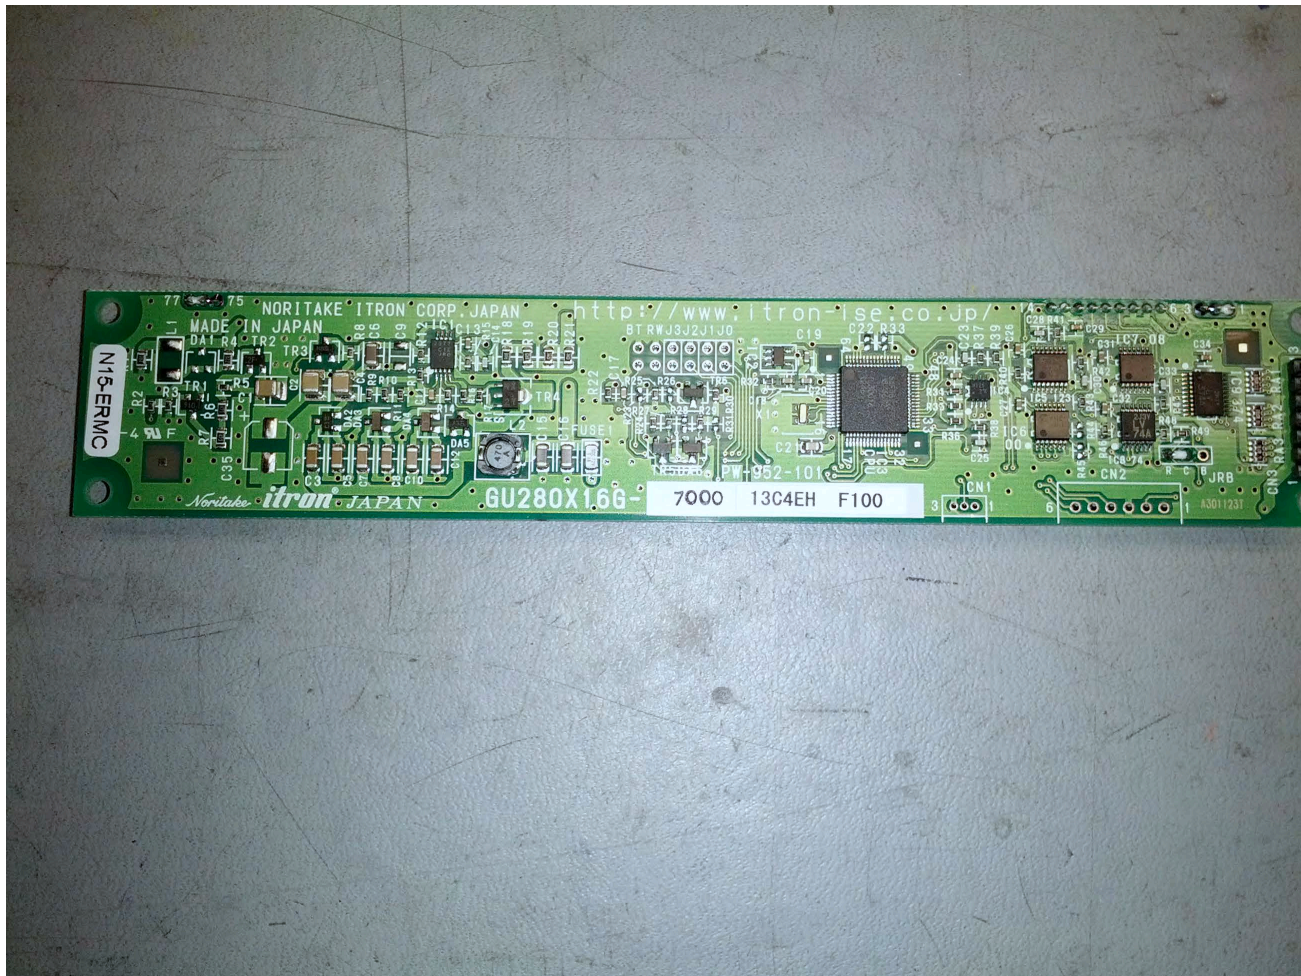
Note the part number GU280X16G-7000 marked on the display PCBA and on the lower left side of the board notice the pads for capacitor C35.

5. On the backside of the Noritake board locate reference designator C35. This location should be unpopulated on the PCBA.

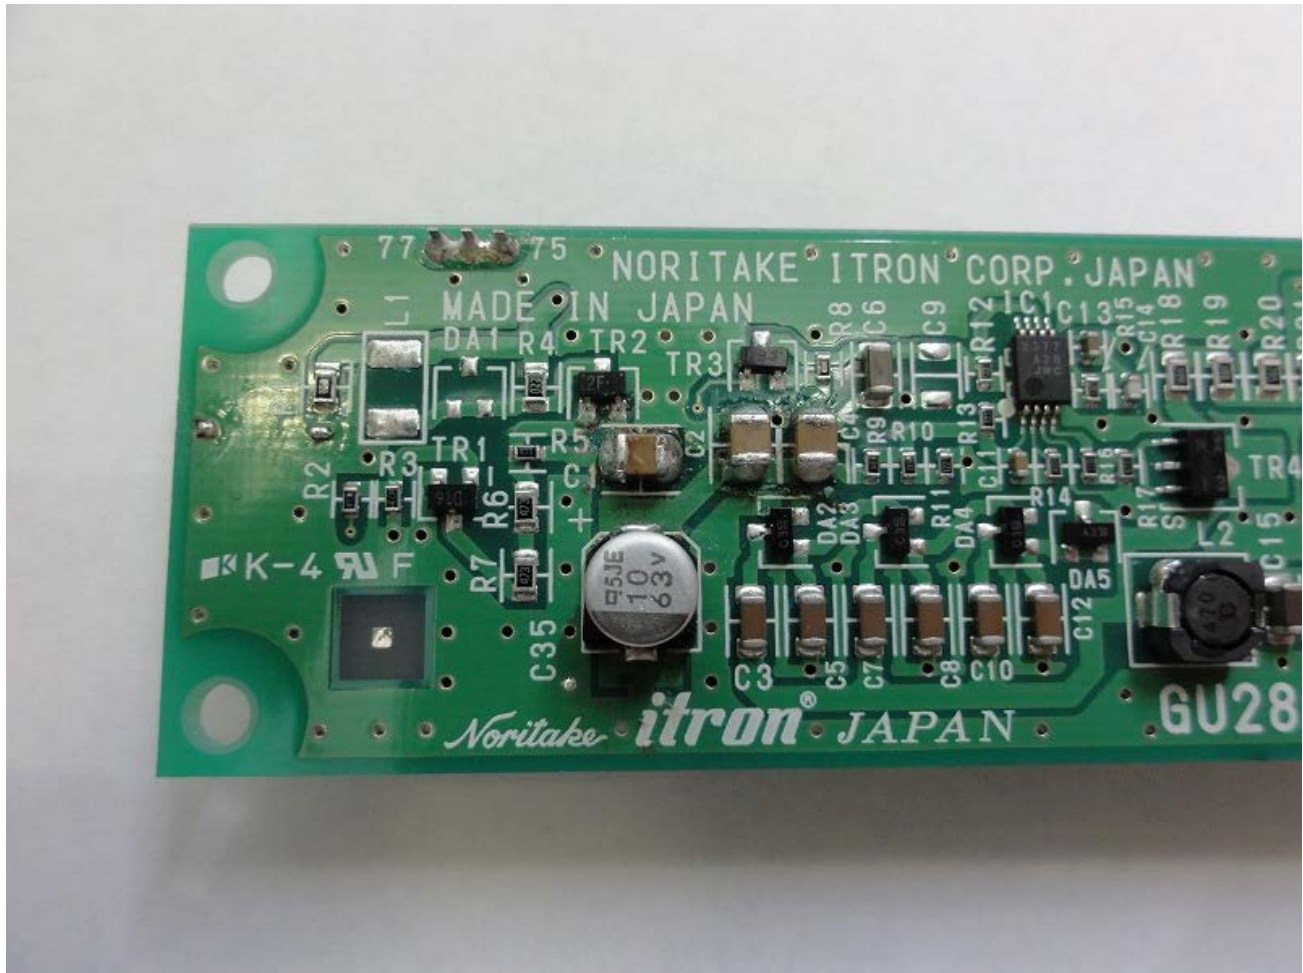
Note that this is a polarized capacitor and the polarity must be maintained in the same orientation as shown in the following photo:

6. Take the 10 uF 63 Vdc electrolytic capacitor (**United Chemi-Con EMVE630ADA100MF55G or equivalent**) and solder to each Noritake PCBA.
