RTS-TB-016**1-May -2013****KP-32 Sector Protection / No Firmware Upgrades Possible**

RTS™ TECHNICAL BULLETIN

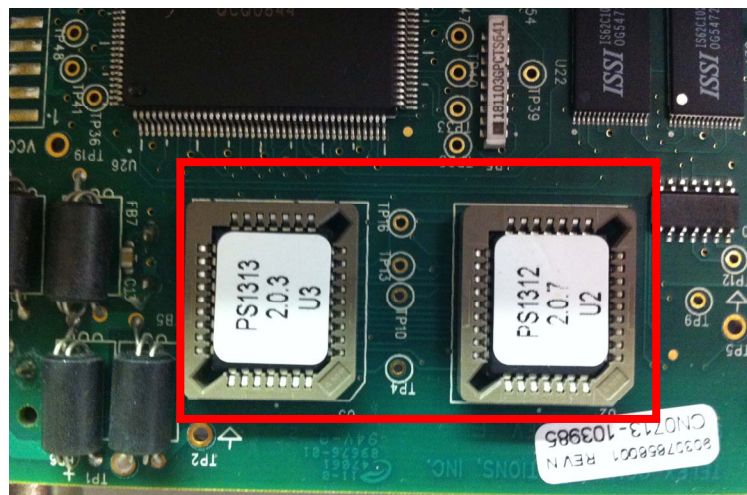
7) Locate U2 and U3 on the main PCBA (F.01U.249.831)
