Reversed Capacitor on RVON Cards Causes Communication Errors

RTS™ TECHNICAL BULLETIN

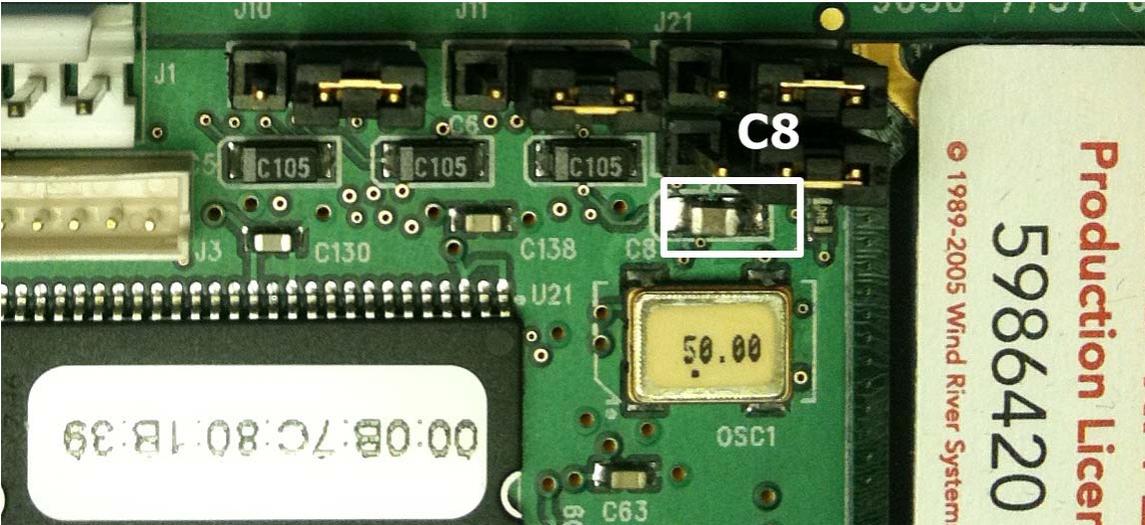
a) RVON 1 & RVON-I/O

Multiple customers have reported communication errors on both the serial and Ethernet links of their RVON networking cards. Additional troubleshooting in the engineering lab revealed that a capacitor had accidentally been reversed in orientation during manufacturing. This reversed capacitor degrades over time and generates communication errors.

This problem can be eliminated by re-work of the reversed capacitor according to the following rework instructions. This rework instruction includes 2 parts:

In case the particular NIC cap is not available, a similar cap can be used, i.e. 1206, 1uF, X7R or X5R, the minimum voltage requirement is 16V.

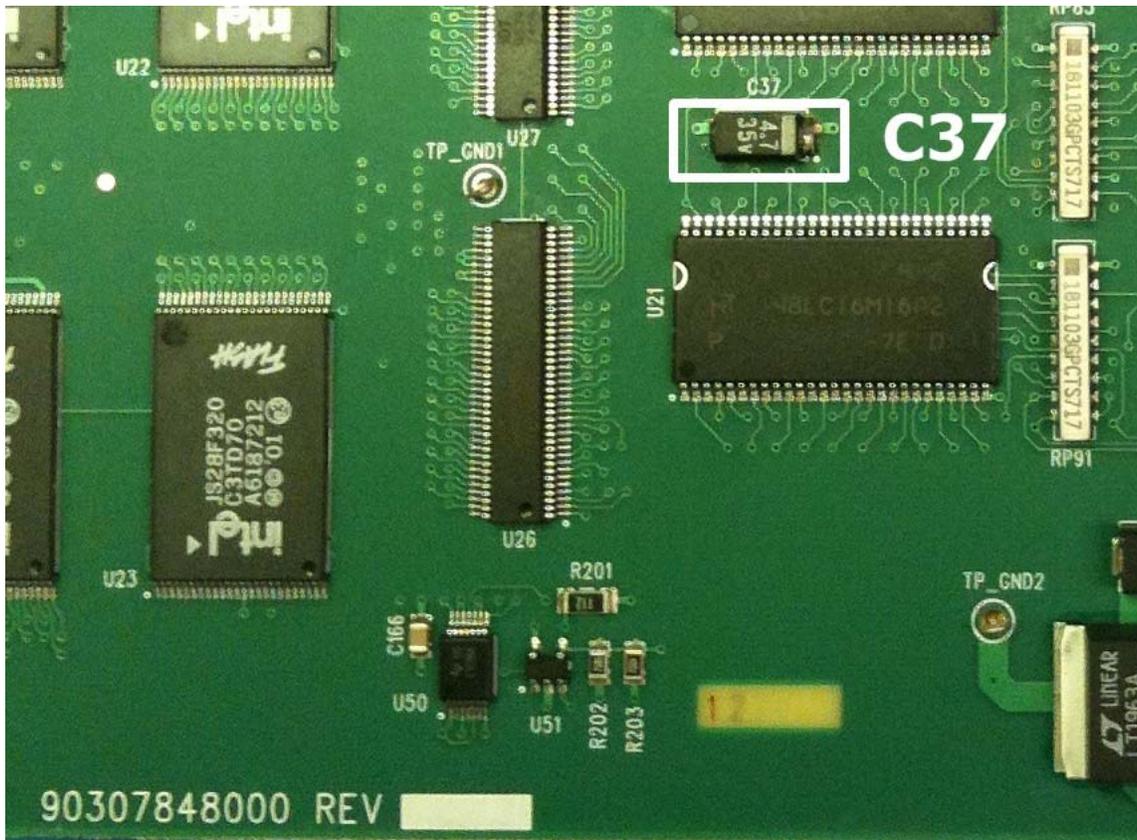
C37 was soldered upside down on RVON-16: 90307848000. It should be replaced with a new capacitor per the silk screen orientation indication dot.

Supplier Part number: 102877027, NIC, NTC-T475K25TRCF or NTC-T475M25TRCF

In the event that the particular NIC cap is not available, a similar cap can be used, i.e. 2412, 4.7uF, tantalum or ceramic, the minimum voltage requirement is 16V.

DO NOT reverse the old cap and solder it back for either modification. **ALWAYS** use a new capacitor.
