KP32 Loss of Audio and Boot Download Failures

CS3310 Modifications

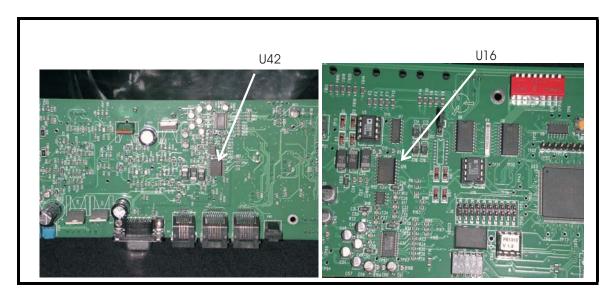
ISSUE: Loss of audio and boot download failures.

- Locate components U16 and U42 (see above) on the 9030-7656-001 KP-32 board.
 - If U16 and U42 are TI part **PGA2311U**, they need to be replaced with **CS3310-KS**.
 - The Telex part number for the CS3310-KS is 5110720-000.
 - For factory replacement of the ICs, please contact:
