Cronus

Release

Notes

Cronus Hardware Release Notes

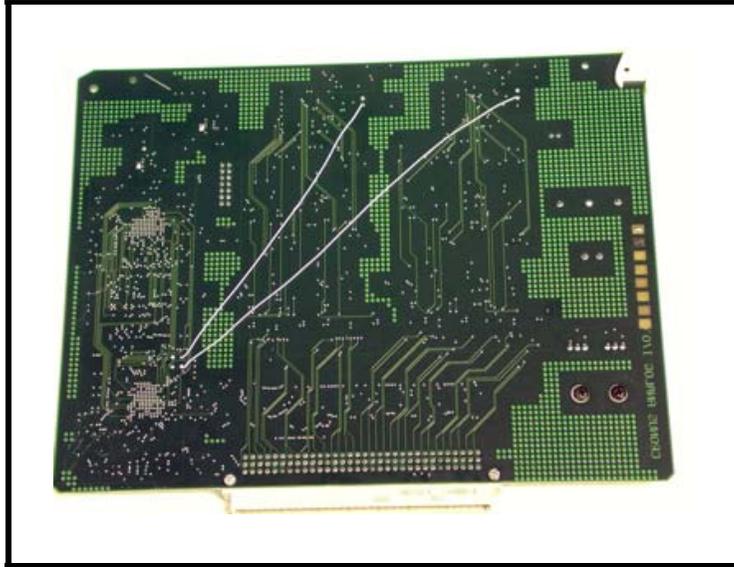
FIGURE 1. Wire Placement on the Cronus Front Card

If you currently have the old Cronus AIO board and need to fix the audio distortion from the CODECs being asynchronous, do the following:

1. Identify test points TP4, TP18, TP19, and TP28 on the front side of the board.
2. Turn the board over to the backside.
3. Using Kynar type jumper wire, connect TP4 to TP18 and TP28 to TP19.
4. Turn the board over to the front side.

5. Using an ohm meter, check for continuity between TP4 and TP18 and continuity between TP28 and TP19.

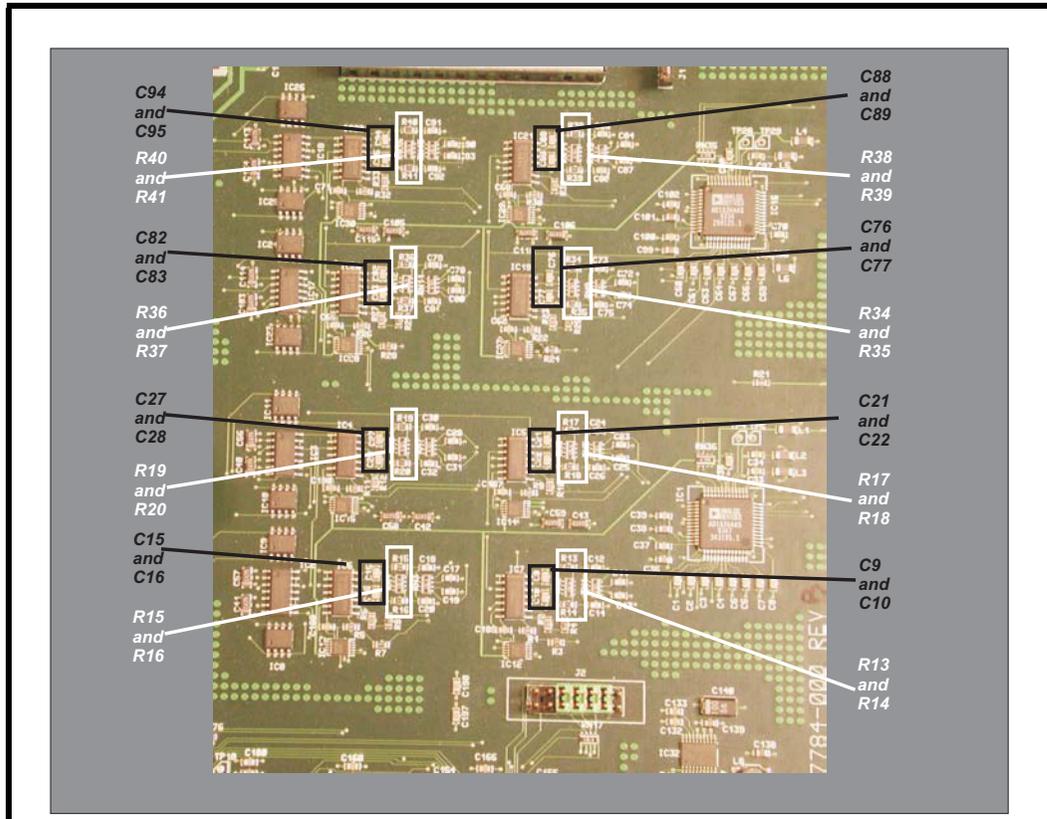
FIGURE 2. Resistors and capacitors that need to change to upgrade the gain amount.

- The analog input/output gain structure of Cronus is not in line with ADAM and Zeus. To upgrade the gain structure, see “Gain Enhancement (Rev C to Rev D)” on page 6.

1. On the front card, replace the following 16 resistors with a 220k resistor (part number 102506-224)

R13, R14, R15, R16, R17, R18, R19, R20, R34, R35, R36, R37, R38, R39, R40, R41

3. On the front card, replace the following 16 capacitors with 12pF capacitor (part number 723411-14). See figure 2.

C9, C10, C15, C16, C21, C22, C27, C28, C76, C77, C82, C83, C88, C89, C94, C95.

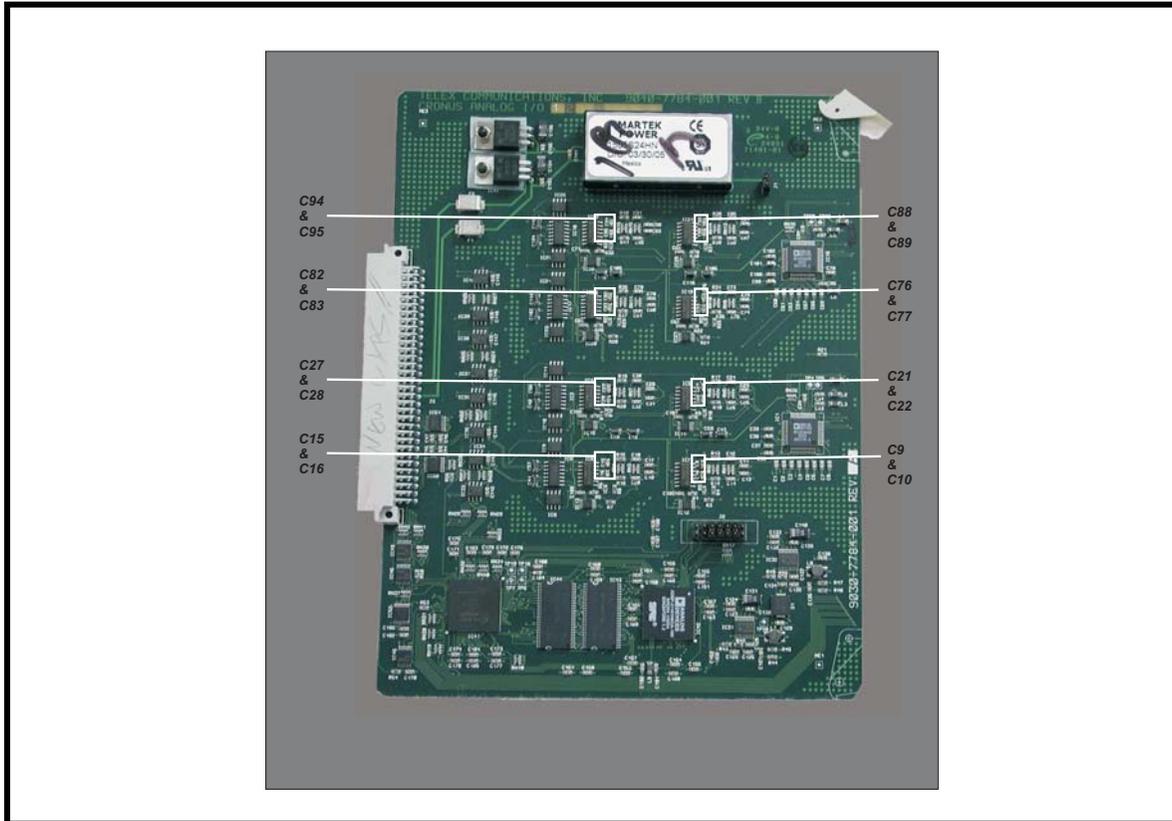
FIGURE 4. New AIO board capacitor placement

It was noticed that the frequency response starts dropping at 10KHz instead of 20KHz as specified in the User Manual.

To fix the Frequency Response problem, an EC #13-000341 was issued to replace 16 capacitors from 100pF to 12pF (part number 723411-14)

The 16 affected parts are C9, C10, C15, C16, C21, C22, C27, C28, C76, C77, C82, C83, C88, C89, C94 and C95.

The modified AIO front card should have the reference markup changed from 9030-7787-001 Rev B to Rev C. See figure 4.

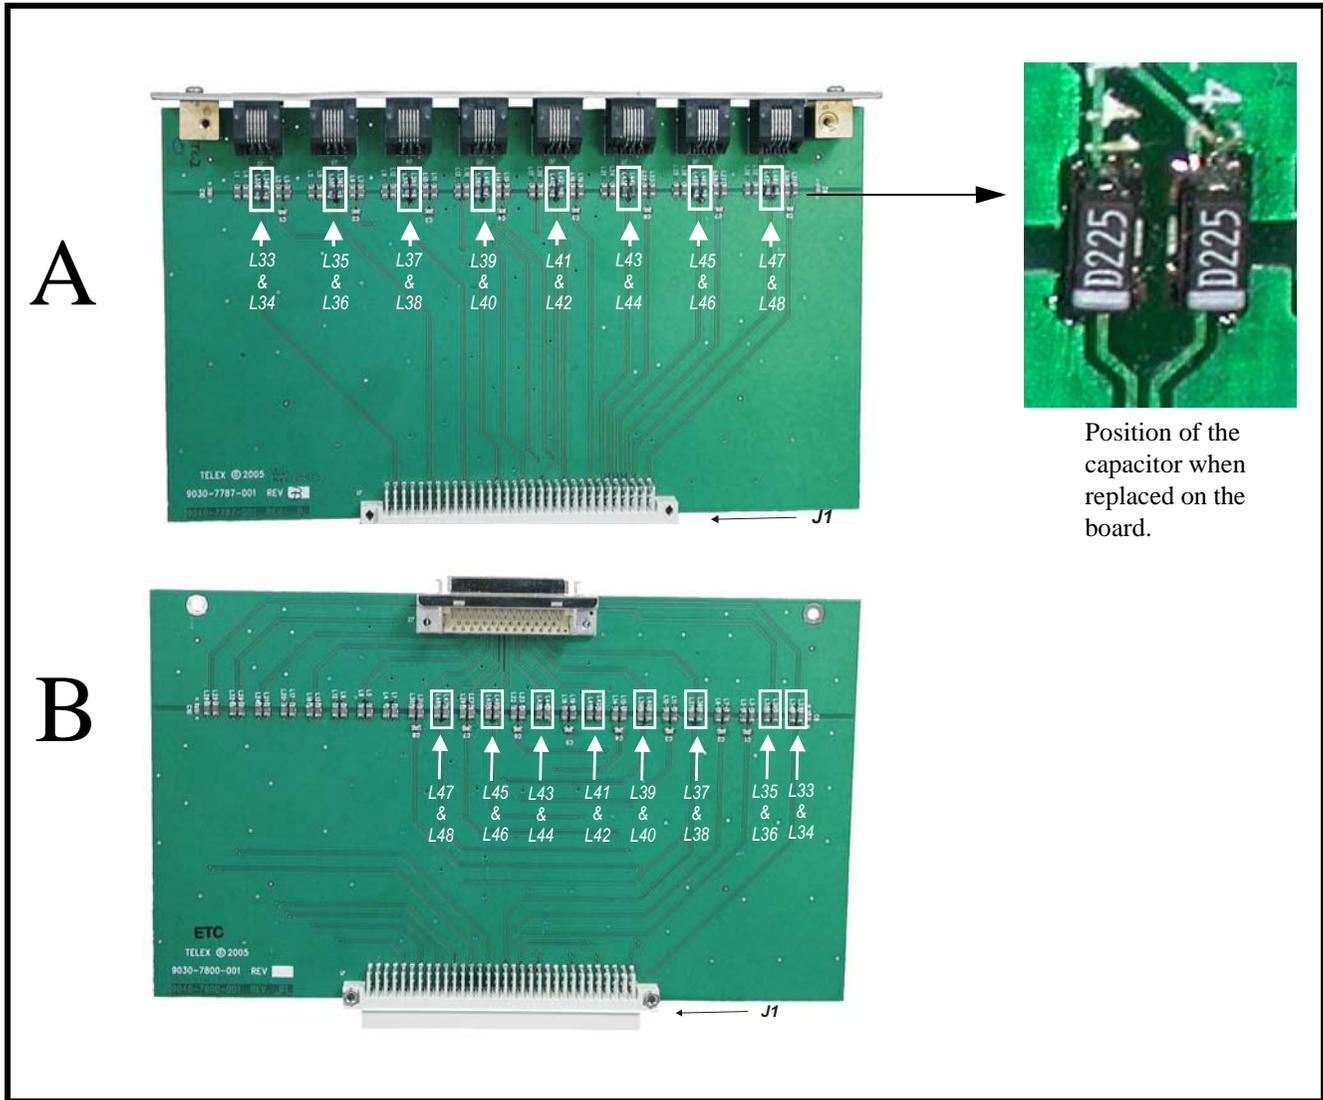
FIGURE 5. Capacitors on the RJ 12 (A) rear card and the MDR (B) rear card.

After changing the design to have an option for analog output gain up to +20dB, the AIO card (9030-7784-001) has exhibited DC bias voltage on the audio output differential pairs of +/- 1.8V.

To fix the DC Bias problem, two ECs were issued to replace the ferrite beads on the audio outputs of the AIO rear cards with DC blocking caps (4.7 uF/16V), part number 102877-070.

EC 46-000351 changes the RJ12 AIO rear card from 9030-7787-001 Rev B to Rev C (See reference A below).

EC 46-000361 changes the MDR Rear Card from 9030-7800-001 Rev A to Rev B (See reference B below).

The 16 affected parts are L33, L34, L35, L36, L37, L38, L39, L40, L41, L42, L43, L44, L45, L46, L47, L48.

IMPORTANT: The positive end of the capacitor should point toward J1 connector (see inset of figure above).

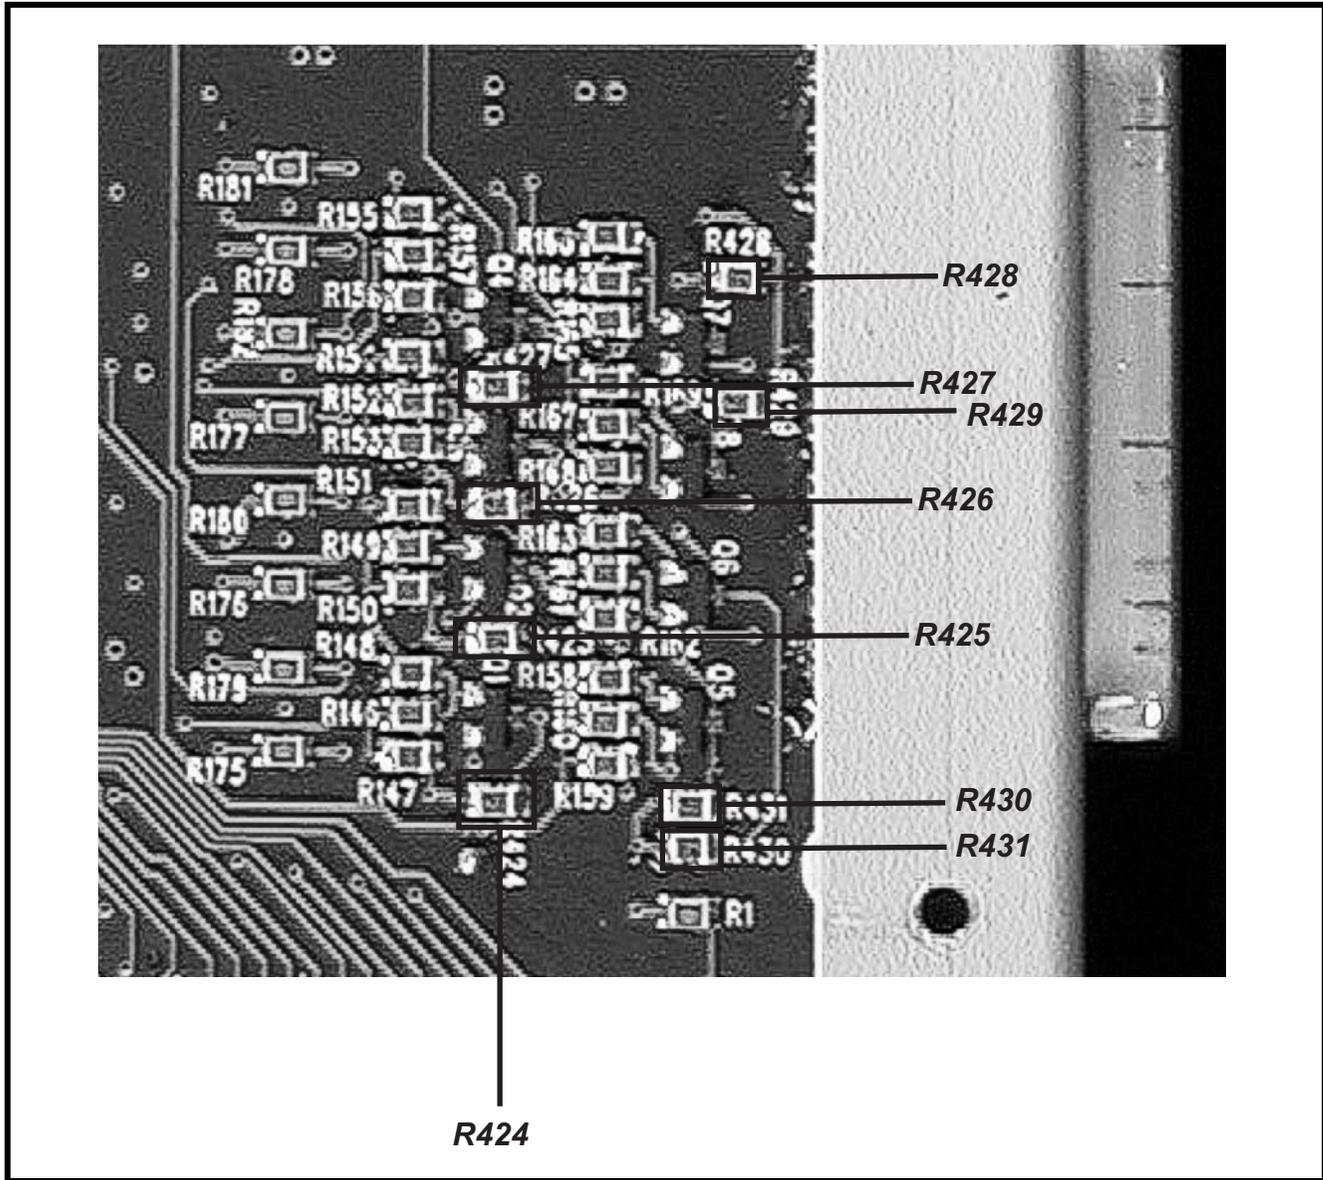
FIGURE 6. Resistor Changes on RVON-I/O (9030-7772-000)

The RVON-I/O's voltage drop across the GPO Output resistor is too large for the Cronus photo coupler GPI. The Cronus series resistor to the photo-coupler is also too large. The voltage drops across both resistors prohibit operation.

To fix this issue, change the RVON-I/O GPO Output from 22.1K to 6.19K on the RVON-I/O card and replace four resistors (R11 through R14) from 3 K to 470 Ohms.

1. On the RVON-I/O card remove 8 resistors (R24 through R431) and replace with 6.19 K resistors (part number 102515-276). See Figure 1 for resistor placement.
