AIO Card ASIC Digital Noise Modification

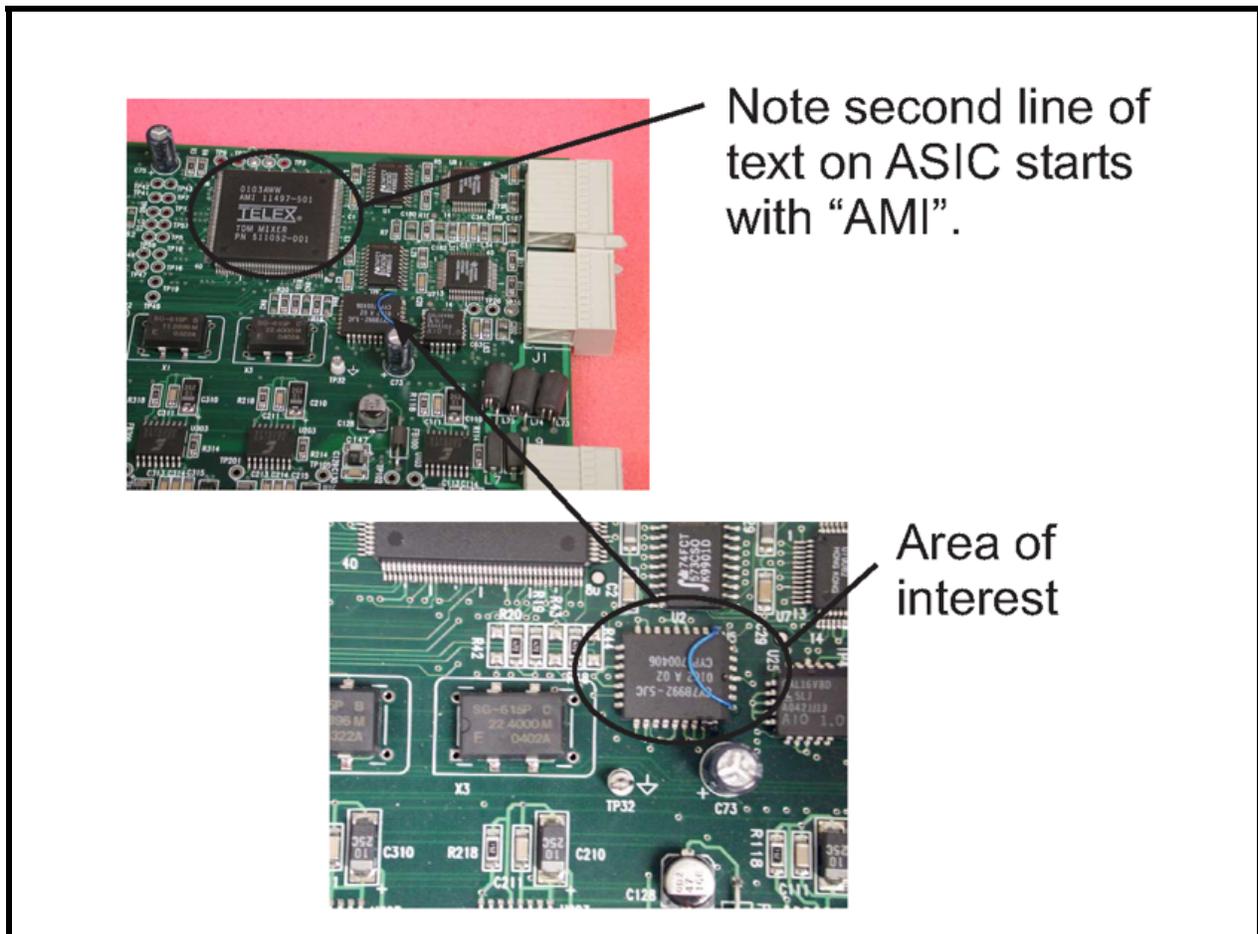
FIGURE 4. ASIC Modifications

An audible sizzling or frying noise can be heard in Port-to-Port audio through the ADAM Matrix. This is more prevalent in end cards.

A timing problem exists in Telex TDM ASICs fabricated by AMI.

1. Using kynar or other suitable jumper wire, **run a jumper from U5 pin 5 to U5 pin 30**, as shown in the photo below.
2. Create a **solder bridge between pins 28 and 29 on U5**.
