### ADAM-M 2.1 Vdc Power Supply Adjustment

# RTS™ TECHNICAL BULLETIN

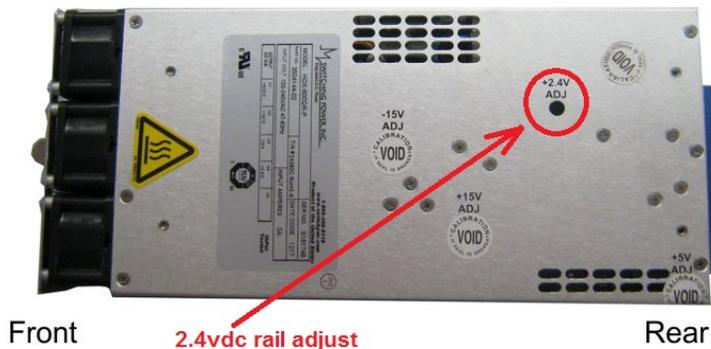
The 2.1 Vdc voltage rail of the ADAM-M frame should not typically exceed 2.28 Vdc. If the voltage rail exceeds this level, this may result in transmission quality errors which are perceived as audio noise in the system. In many cases, this noise has been described as ‘crackling’ or ‘popping’ noises.

- 1) **Power off both AC/DC supplies in the ADAM-M Frame.**
- 2) Keep all system cards in the ADAM-M frame so that a static load remains on the power supply
- 3) Remove one (and only one) of the AC/DC power supplies
- 4) Locate the 2.1 Vdc rail adjustment opening on the top of the supply. It is labeled "+2.4V ADJ" and is identified in the picture below:

If the 2.1 Vdc rail is found to be in excess of 2.28 Vdc, it is definitely necessary for an adjustment to be made to reduce the voltage level on this rail. This procedure is described in the following section.
