RTS-TB-029**20-June-2014****RP-1000 Microphone Gating Rework**

RTS[™] TECHNICAL BULLETIN

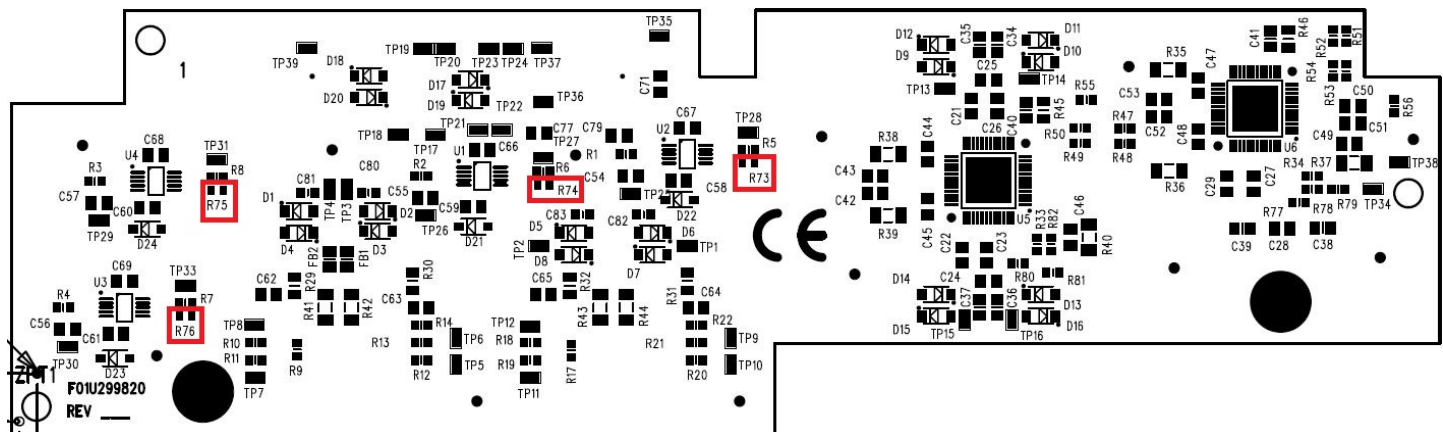
There have been several field complaints from various regions regarding a gating behavior on the RP-1000 microphone circuits (both headset and panel). This behavior was originally seen on early CLD panels before a change was made to a component value in the design. As part of the recent move of the analog PCBAs from one manufacturing facility to another, this change was omitted on RP-1000 builds. As such, an audible gating effect has returned to the microphones on the unit.

1. Locate gating resistor reference designators R73, R74, R75 and R76 according to the assembly drawing below.

In order to address this issue, four resistors need to be replaced on the analog daughter card of the RP-1000. These resistors effectively disable the gating behavior of the analog compression ICs present on all microphone circuits. This returns the behavior to the same performance as the previous CLD panels.

2. Remove and discard the existing resistors located at locations R73, R74, R75 and R76.
3. Solder the 30.1 kOhm 0603 1% 0.1W part (F.01U.013.116 or equivalent) onto R73, R74, R75 and R76.
4. Re-assemble PCBA into RP-1000 and re-test for proper operation.
