## Audio Noise on Channels due to Improper Resistor population on Tribus / MADI Front Cards

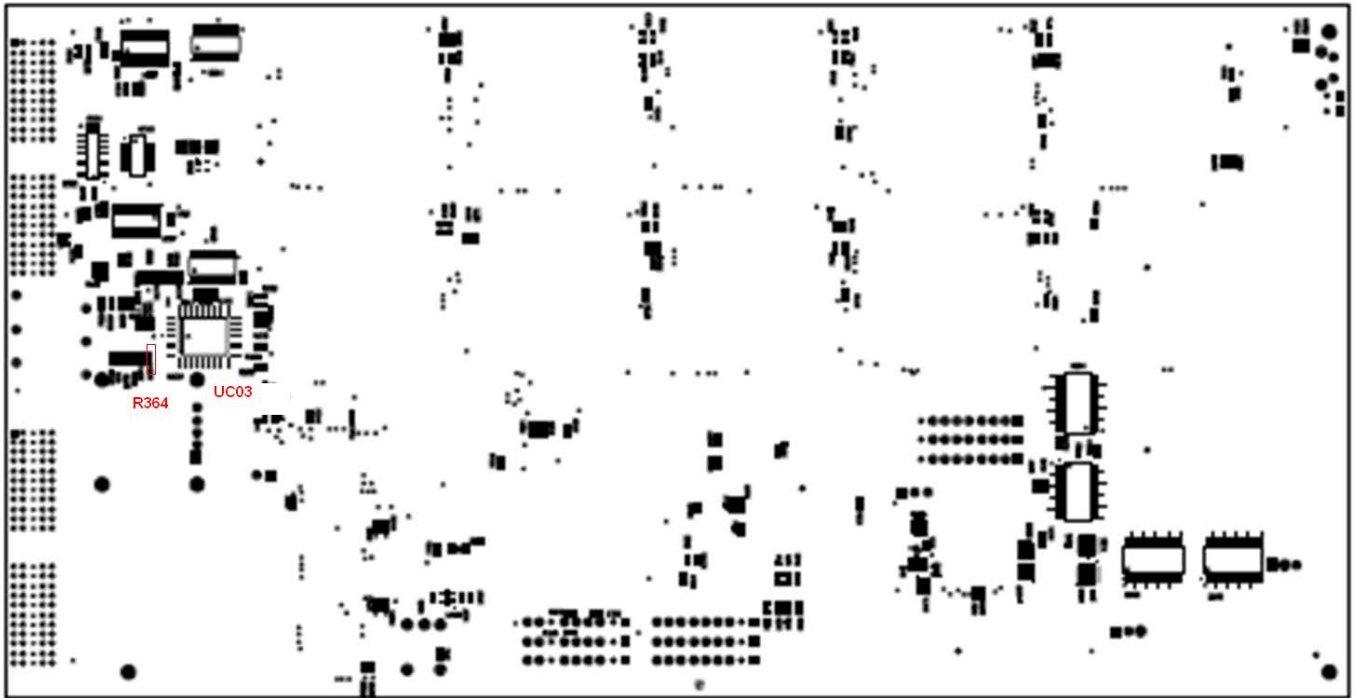
Field issues have been reported and confirmed in which timeslots in the ADAM matrix system have experienced noise due to the timing design of the Tribus & MADI Front Cards. A common Front Card is used for both the Tribus and MADI applications with the only difference being software programmed onto each card. It should be noted that this problem was originally discovered on the Tribus module prior to the production release of the MADI. The resistor should NEVER have been populated on the MADI Front Card builds. However, both engineering and tech support have verified a number of MADI Front Cards shipped new from the factory which have had this resistor populated in the field. As such, this issue should be inspected on these cards for any system where noise is present.

The circuitry in question is confined to the Tribus / MADI Front Card. No issues are present on the Tribus Back Card or MADI Back Card. The noise occurs on any AIO-16 card or other interface card that has small margins for the TDM bus set-up and hold time.

This issue typically shows up on the first port of a card but under worst-case conditions can affect every channel assigned to that card. For example: If an AIO-16 in Slot 2 is assigned to ports 17 – 32, the noise would typically be detected on port 17.

R364 (located on the back side of the Tribus / MAD1 Front Card) should be removed from all Front Cards. This is shown in the following assembly view:

The Engineering Changes which documented the removal of this resistor are EC# 46-002068 and EC# 46-002122.
