RVON-I/O

Release

Notes

Since the release of the RVON-I/O card, a few issues have surfaced pertaining to the original card. This document covers these issues and how to fix the existing RVON-I/O board to solve these issues.

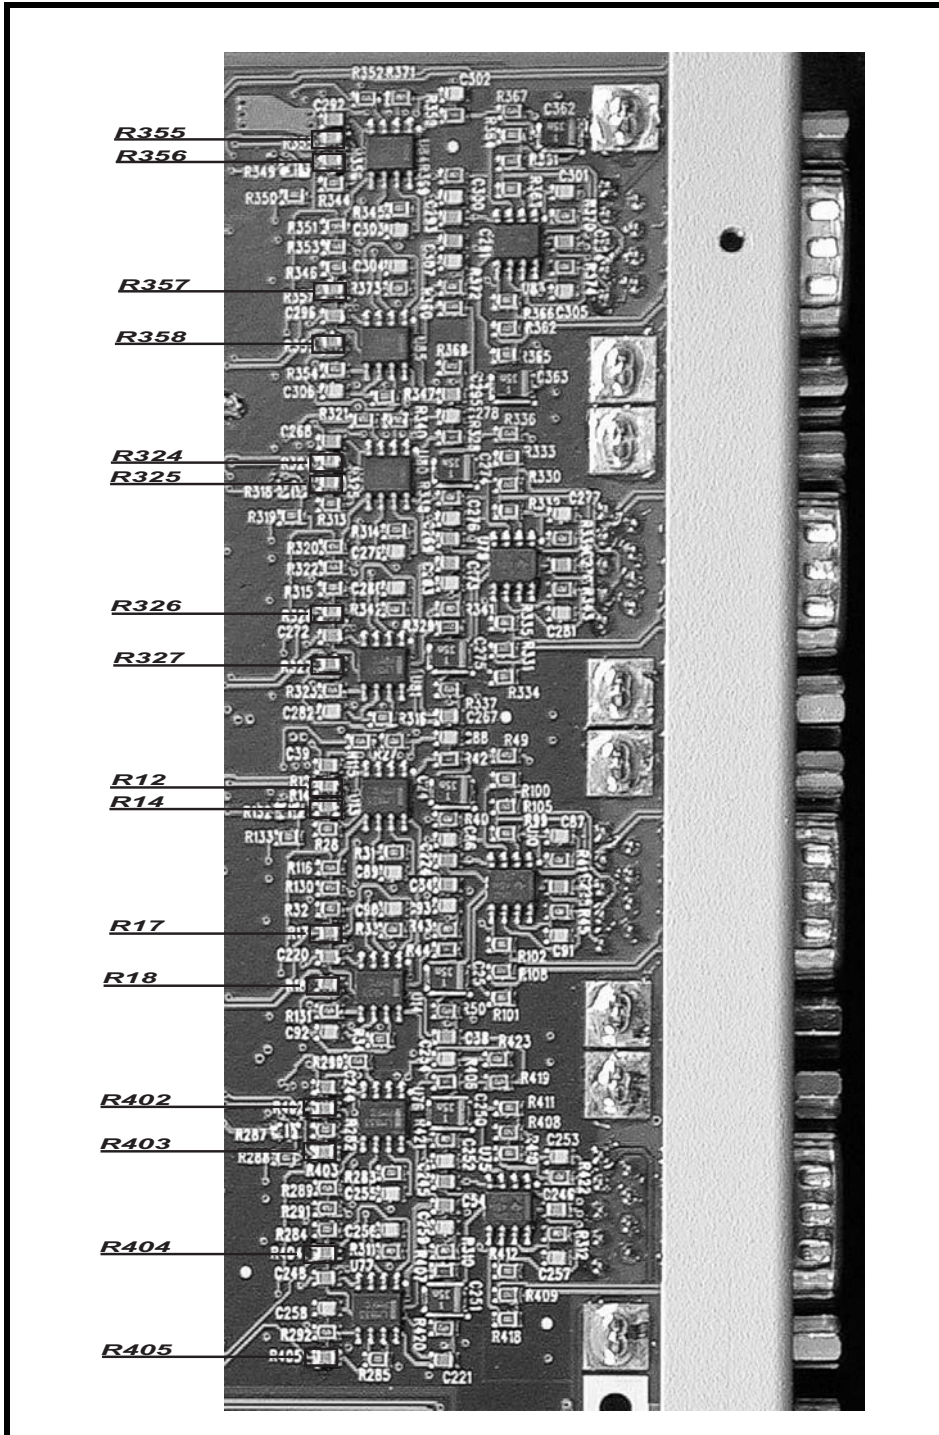
Crosstalk on the same channel

The output to the matrix is being heard on the same channel's input. The input to the Codec need to be AC coupled. To fix the crosstalk on the same channel, you must remove 16 resistors (150Ohm) - **R12, R14, R17, R18, R324 - R327, R355 - R358, R402 - R405** and replace with 16 capacitors (part number **102881-880**, 0.47 uF 16V) in **R12, R14, R17, R18, R324 - R327, R355 - R358, R402 - R405**. For replacement positions, see figure 1.

FIGURE 1. Crosstalk Resistors to Capacitors placement (board number 9030-7772-000).

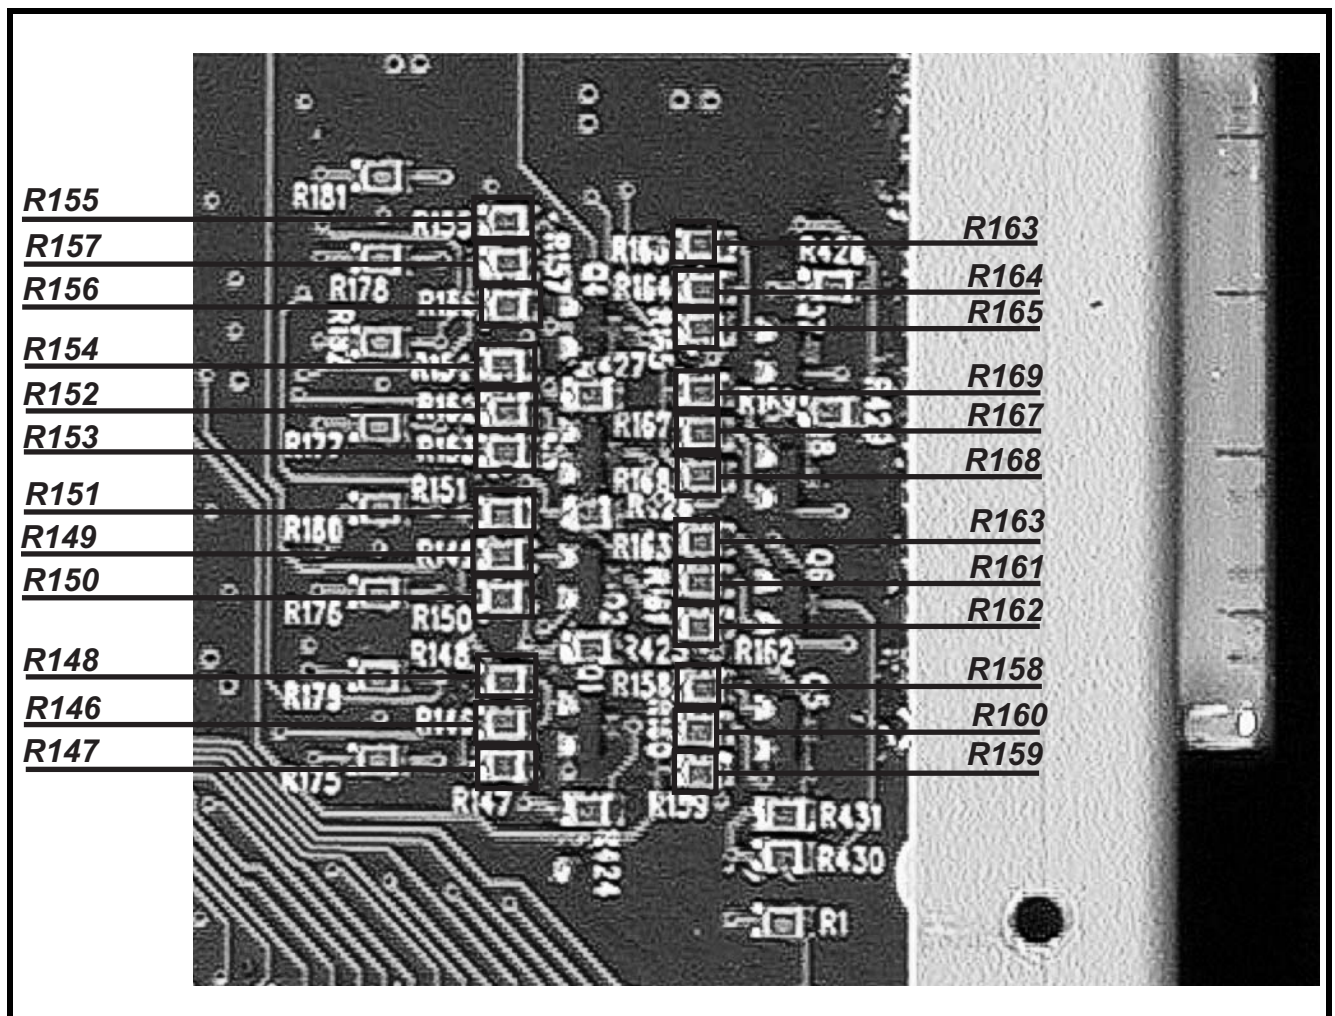
When the RVON-I/O GPIO is connected to an ADAM frame with Redundant Controller Cards Installed, the RVON-I/O GPO is not able to drive both MCIIe GPI

The GPO transistor can't handle the current load for a dual Master Controller chassis. The GPO transistor's input resistors need to be reduced to increase the base current. This will increase the collector current's load.

FIGURE 2. Resistor Placement (board number 9030-7772-000).

To fix this issue, change the 3 input resistors of each GPO from 22.1K to 2K. This increases the collector current from ~10 mA to ~60 mA. The transistor can handle 200 mA.

Also, remove 24 resistors, **R146 through R169** and replace them with 2K resistors (part number **102515-229**). See figure 2 for resistor placement.

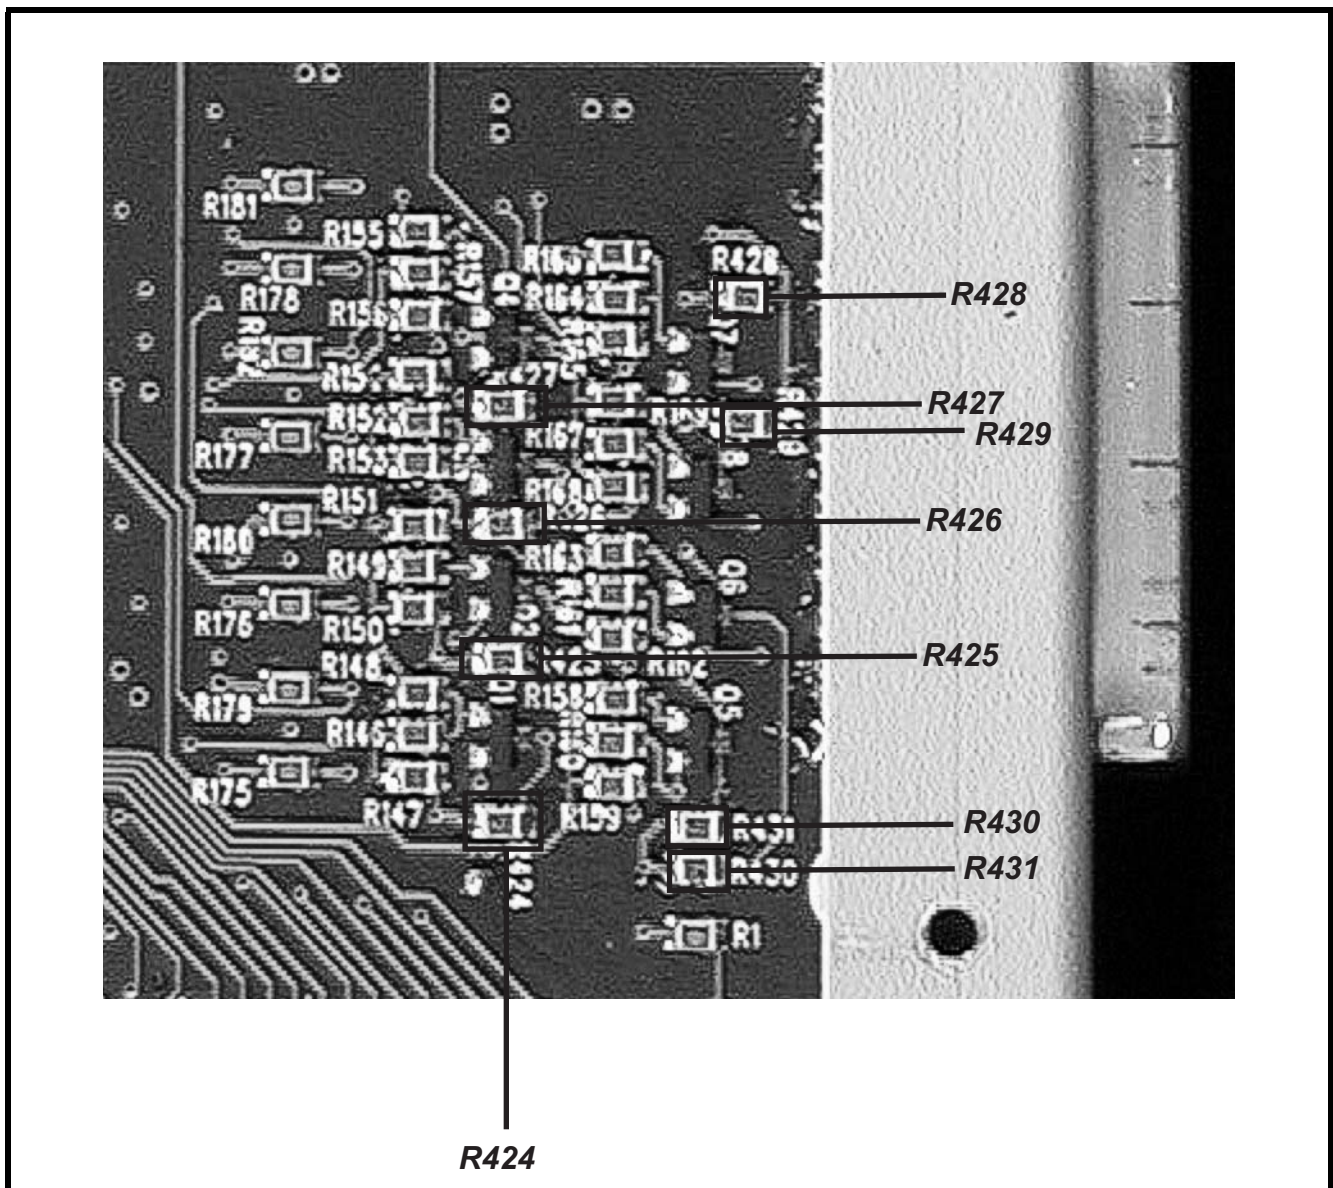
When the RVON-I/O is connected to a Master Controller in a Cronus chassis, is not able to drive the Cronus GPI

The RVON-I/O's voltage drop across the GPO output resistor is too large for the Cronus photo coupler GPI. The Cronus series resistor to the photo-coupler is also too large. The voltage drops across both resistors prohibit operation.

FIGURE 3. Resistor Changes

To fix this issue, change the RVON-I/O GPO Output from 22.1K to 6.19 K on the RVON-I/O card and replace four resistors (R11 through R14) from 3 K to 470 Ohms.

1. On the RVON-I/O card, remove 8 resistors (**R424 through R431**) and replace with 6.19 K resistors (part number **102515-276**). See figure 3 for resistor placement.

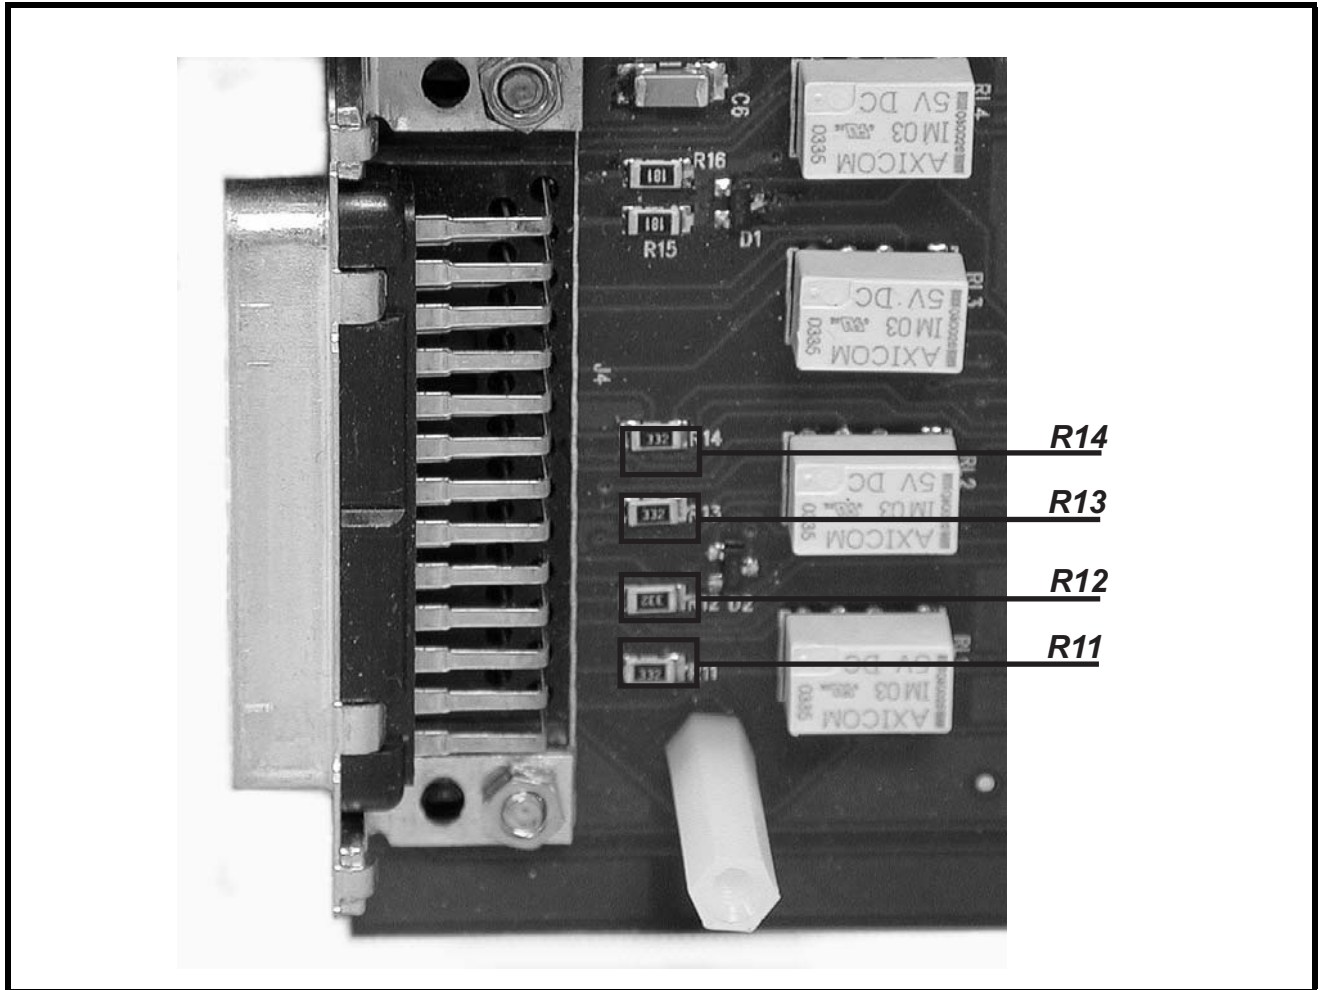
FIGURE 4. Cronus board resistor placement. The Cronus Master Controller board will go from 9030-7788-001 Rev A to 9030-7788-001 Rev B

2. On the Cronus MC Back card, remove the 3K resistors (**R11 through R14**).
3. Replace with 470 Ohm resistors (part number **102513-471**).
