**RTS-TB-035****18-April-2017****Low frequency Noise / Hum heard on Zeus III audio**

**1.0 Issue**

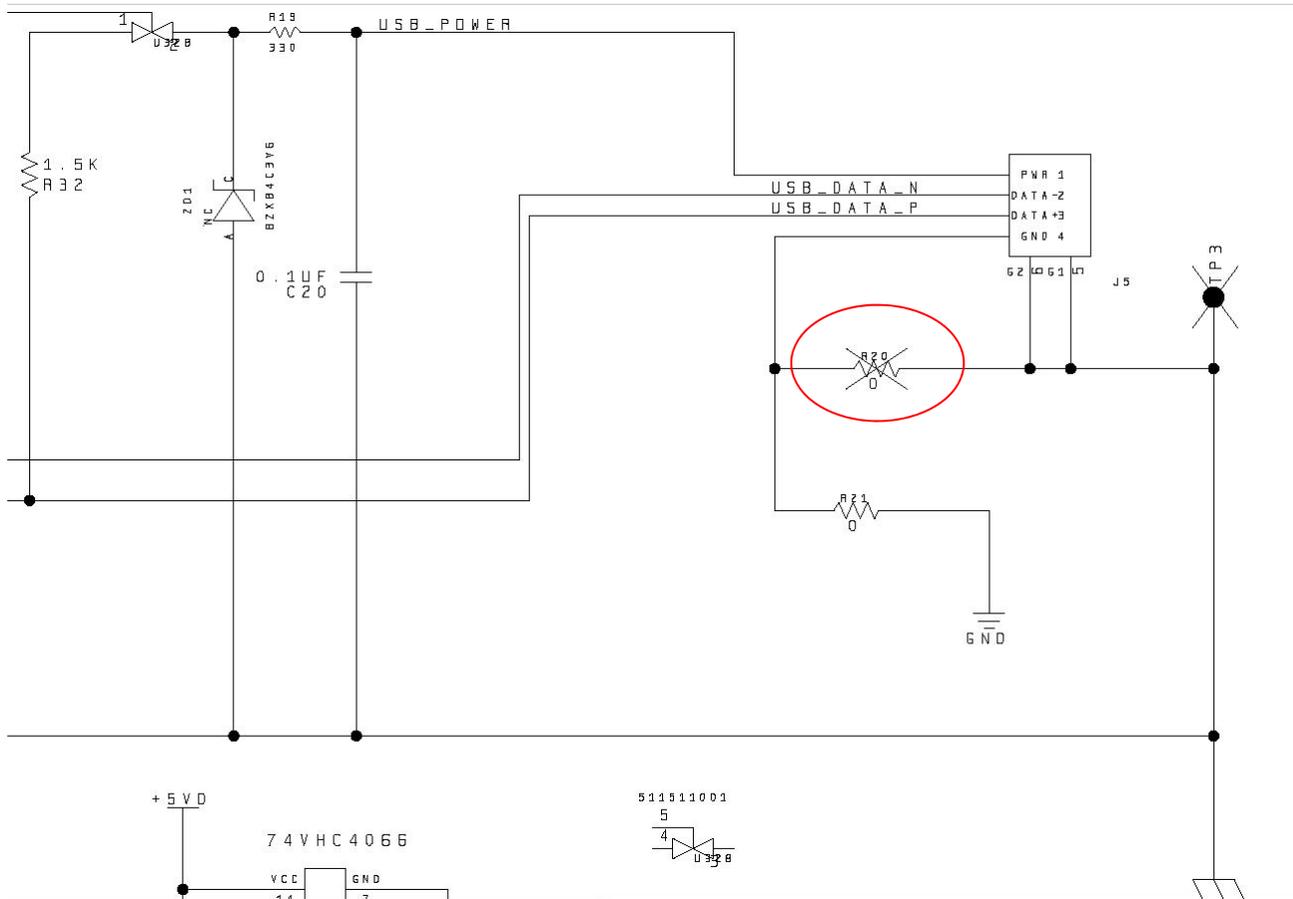
Engineering believes that this issue is caused on certain panels by a high impedance between frame ground and circuit ground internal to the Zeus III design. This creates the environment for ground noise on the audio lines.

The following shows the schematic with R20. The “X” over the resistor symbol indicates the resistor is currently not populated. Note that if populated, R20 would connect circuit ground to frame ground on the Zeus III Main PCBA. Connector J5 is the USB port on the front of the Zeus III.

Bosch recommends a simple rework which we believe will address this issue. The schematics and PCBA layout of the Zeus III Main PCBA contains a resistor R20 which is currently depopulated on shipments. This resistor is a 2010 package geometry. If this resistor is replaced with a 0 Ohm equivalent (or the pads simply shorted together), this should eliminate the noise issue and create the same benefit that connecting an external USB device has.

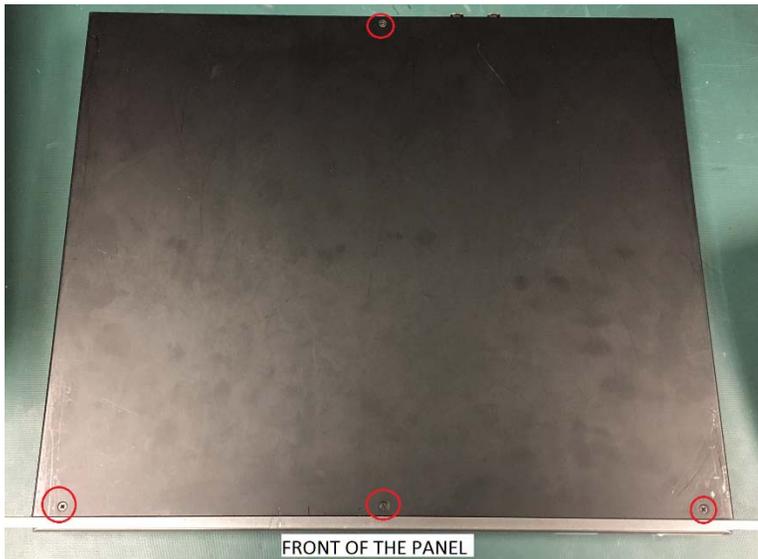
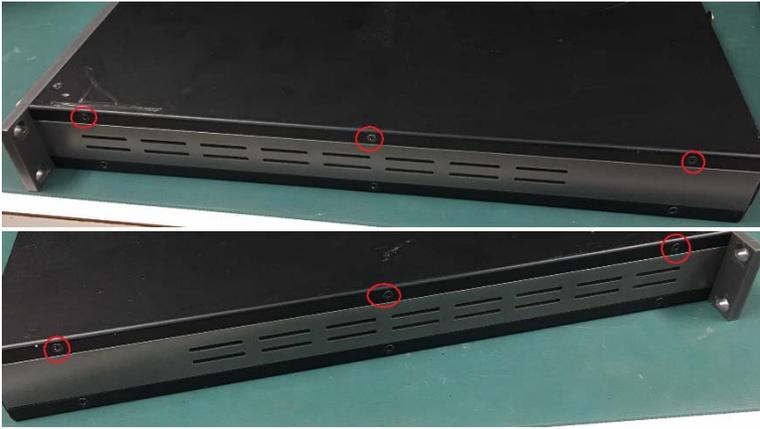
1. Remove AC power from the ZEUS panel and place the panel onto an ESD safe work surface.
2. Remove the top cover from the ZEUS panel by unscrewing 10 Phillips drive flat head screws (4 on top and 3 on each side):

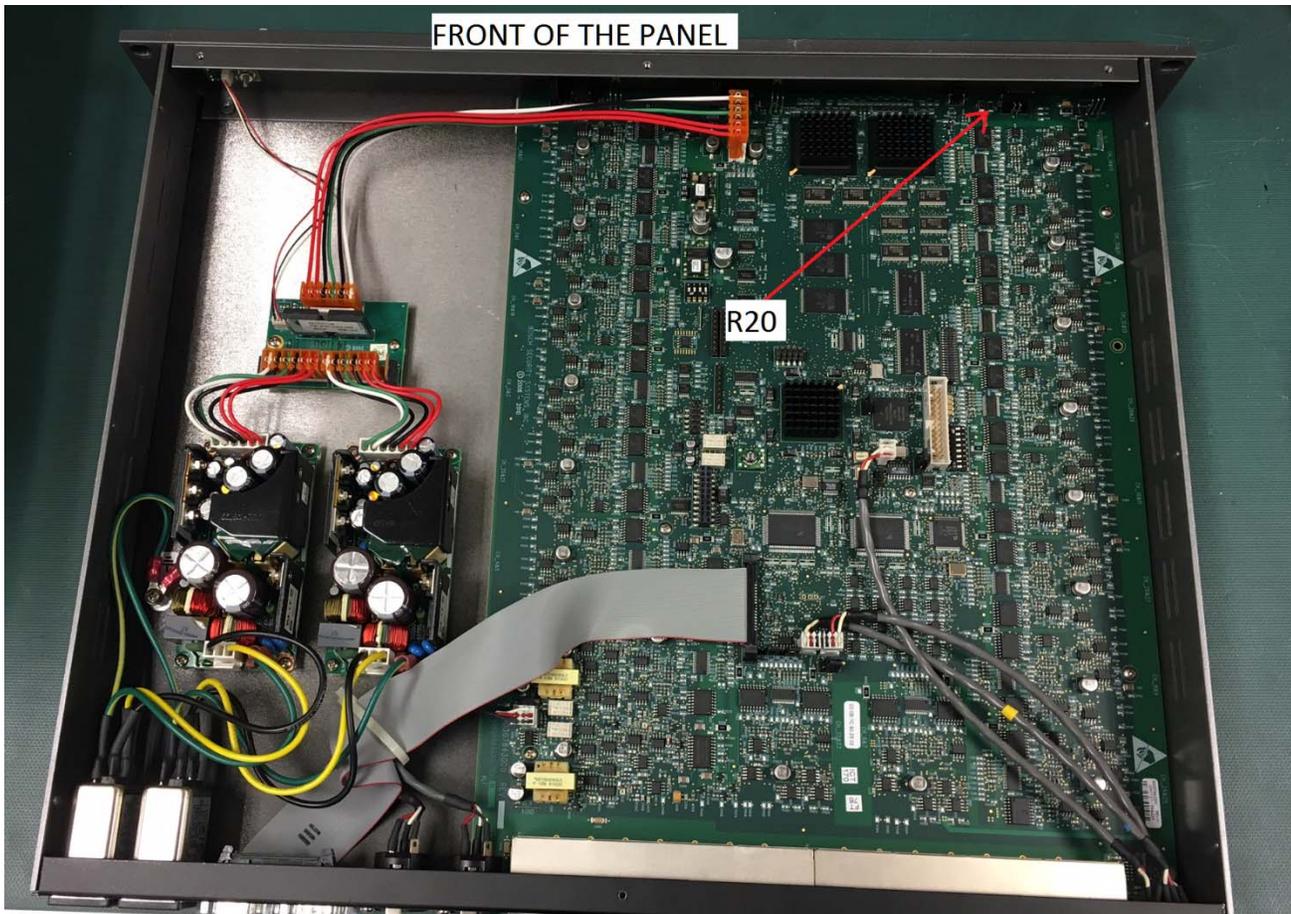
3. Identify resistor pads location R20 on the Main PCBA. Refer to the following pictures that show the resistor pads location R20.
