Cronus

Release

Notes

Cronus Hardware Release Notes

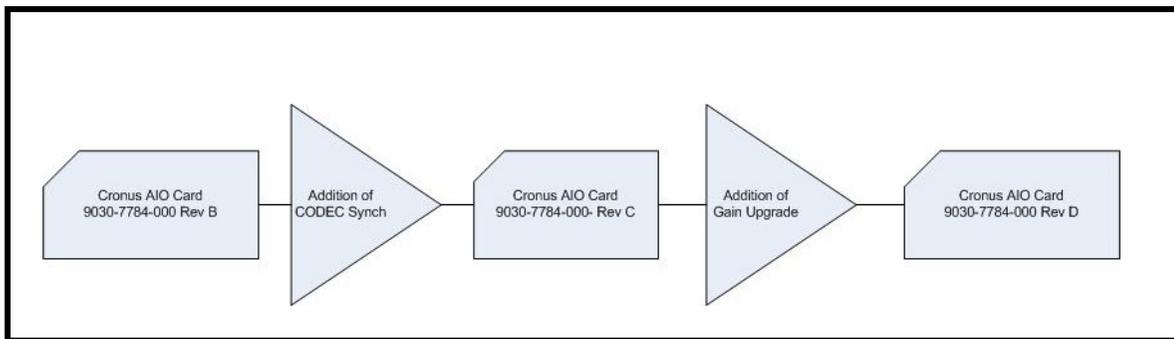
TABLE 1. Revision Progression on the Cronus Front Card 9030-7784-000.

- The analog input/output gain structure of Cronus is not in line with ADAM and Zeus. To upgrade the gain structure, see “Gain Enhancement (Rev C to Rev D)” on page 6.

NOTE: If the card you have is 9030-7784-000 Rev D or higher, it has already been modified and does not need to be upgraded.
