**AIO-16 Memory Write Corruptions / Keypanel Lockout**

**1.0 Issue**

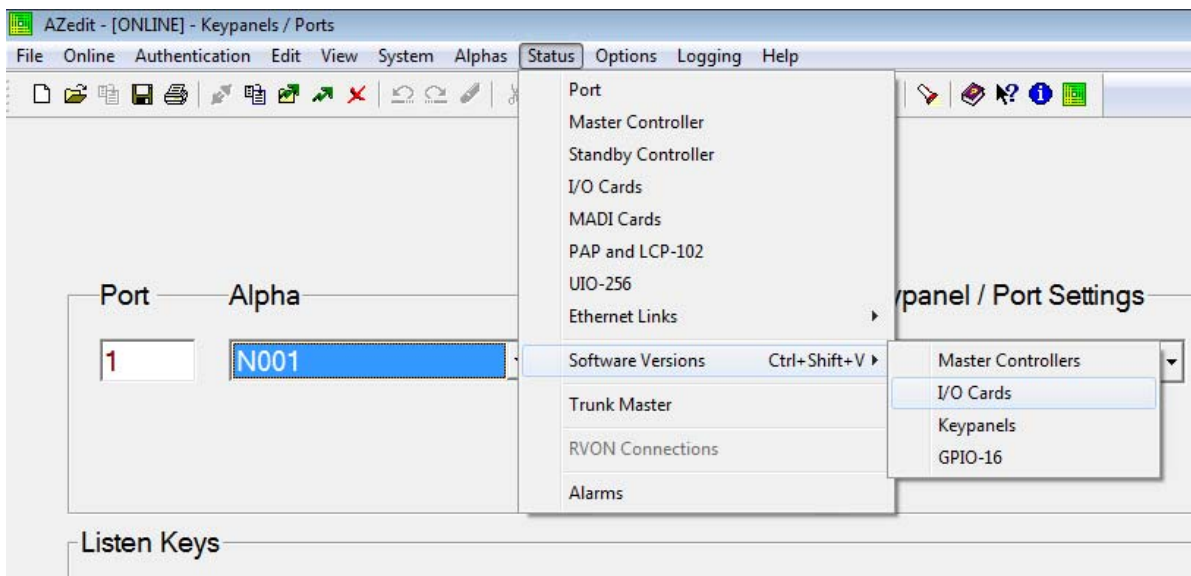
- 1) Insure firmware and FPGA upgrade files are located in a known directory.
- 2) Open AZedit on a PC connected to the system controller (e.g. MCII-e). Insure communication between the PC and system controller is configured correctly.
- 3) Navigate to the Software Versions screen for I/O Cards.

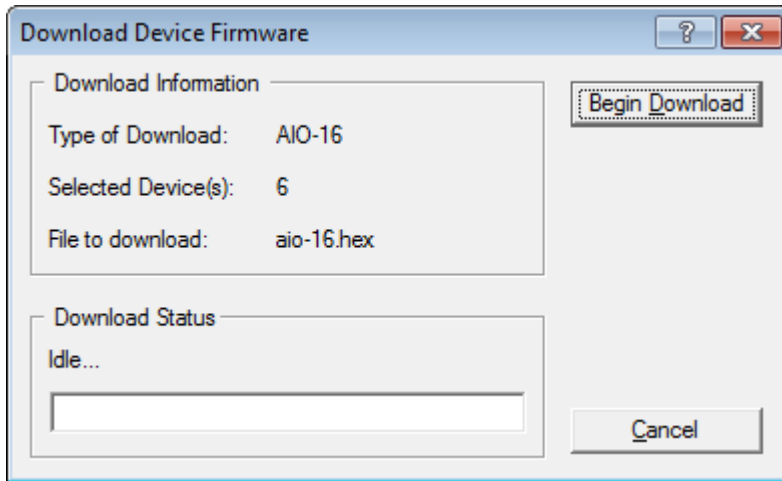
- 5) In the Firmware Download window, navigate to the directory containing the application firmware upgrade file "aio-16.hex". Select the upgrade file and click "Open" and then select "Begin Download". **CAUTION: Do not reset the AIO-16 or remove power until step (7) is complete.**

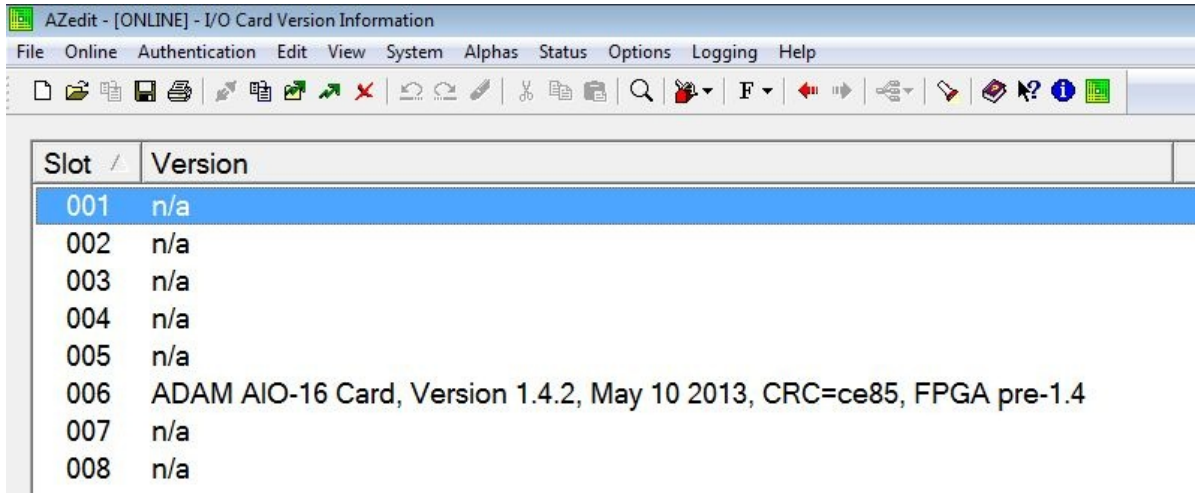
- 7) Verify successful application firmware upgrade of the AIO-16. The AIO-16 card should report Version 1.4.2. Note the FPGA version is "pre-1.4".

The screenshot shows a web-based interface titled "AZedit - [ONLINE] - I/O Card Version Information". It features a menu bar with "File", "Online", "Authentication", "Edit", "View", "System", "Alphas", "Status", "Options", "Logging", and "Help". Below the menu is a toolbar with various icons. The main content area displays a table with two columns: "Slot" and "Version".

Slot	Version
001	n/a
002	n/a
003	n/a
004	n/a
005	n/a
006	ADAM AIO-16 Card, Version 1.4.2, May 10 2013, CRC=ce85, FPGA pre-1.4
007	n/a
008	n/a

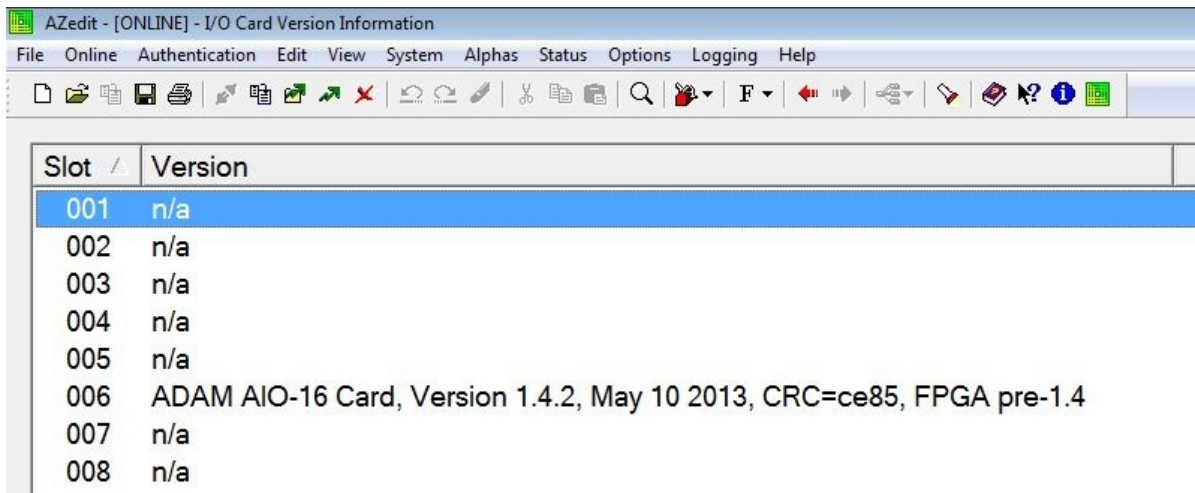
- 8) Repeat steps 4 through 6 **except use FPGA upgrade file "aio-16\_FPGA.hex"**. After the pop-up window shown in step (6) appears, observe the two red LEDs on the AIO-16 front card (nearest to the reset button). After approximately 10 seconds, the LEDs will blink and then remain off. At this time, the Software Versions screen will show "n/a" temporarily. The AIO-16 will then report the following version:

The screenshot shows the same web-based interface as above, but the table content has changed. The "Version" for slot 006 is now "ADAM AIO-16 Card, Version 1.4.2, May 10 2013, CRC=ce85, FPGA pre-1.4".

Slot	Version
001	n/a
002	n/a
003	n/a
004	n/a
005	n/a
006	ADAM AIO-16 Card, Version 1.4.2, May 10 2013, CRC=ce85, FPGA pre-1.4
007	n/a
008	n/a

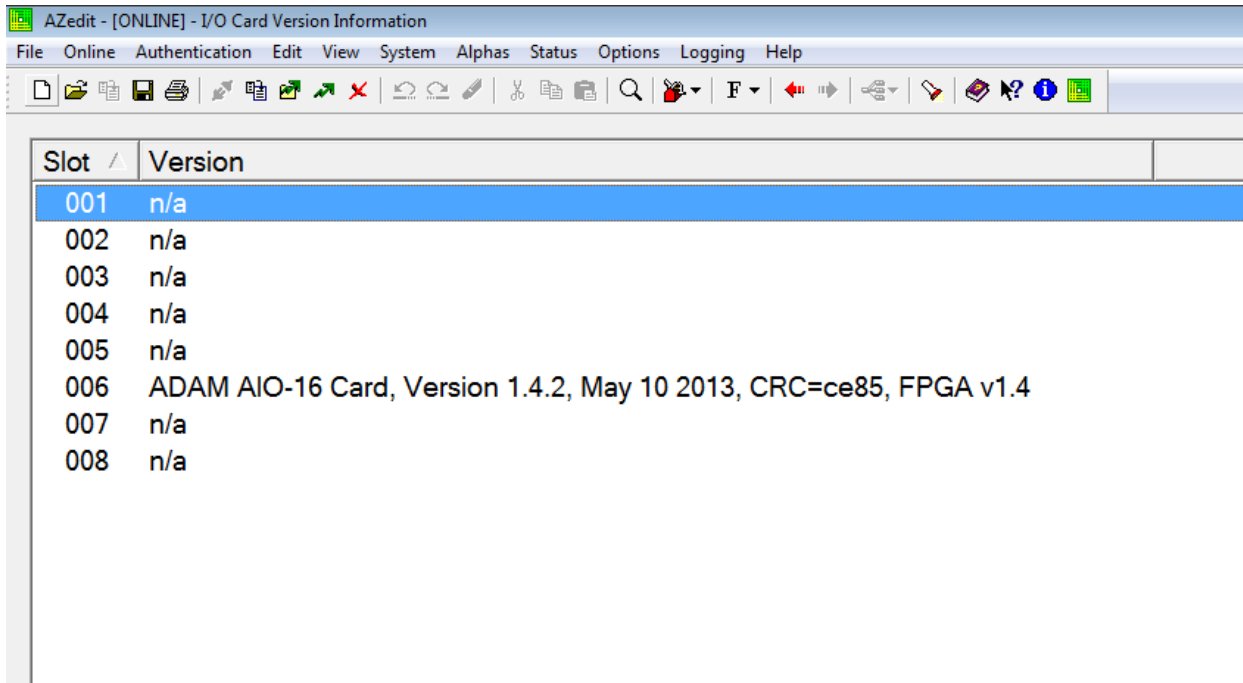
- 9) The AIO-16 still reports "FPGA pre-1.4". At this time, the FPGA upgrade file is downloaded into flash memory but the FPGA has not reconfigured. Reset the AIO-16 using the push button to reconfigure the FPGA. The AIO-16 now reports the following version:

Slot	Version
001	n/a
002	n/a
003	n/a
004	n/a
005	n/a
006	ADAM AIO-16 Card, Version 1.4.2, May 10 2013, CRC=ce85, FPGA v1.4
007	n/a
008	n/a
